123 Any Drive, Franklin, TN

193 Heathersett Dr., Franklin, TN 37064 (615) 791-7433 Steve Traylor, owner/inspector

HOME INSPECTION REPORT

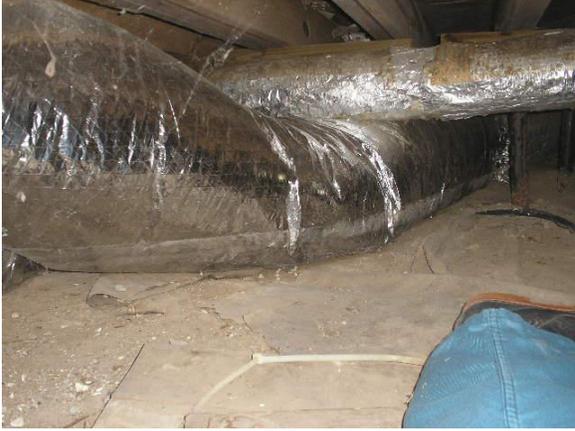
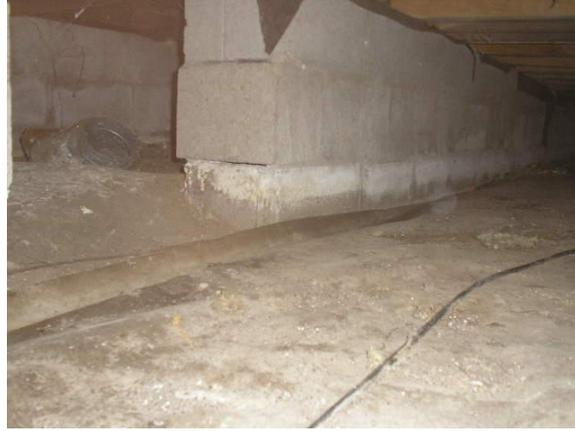
2.
3. I see about a 6" high water/mud stain up on the ductwork lying on the ground and on concrete block walls in the crawl space where water probably flowed into the crawl space vents at ground level.

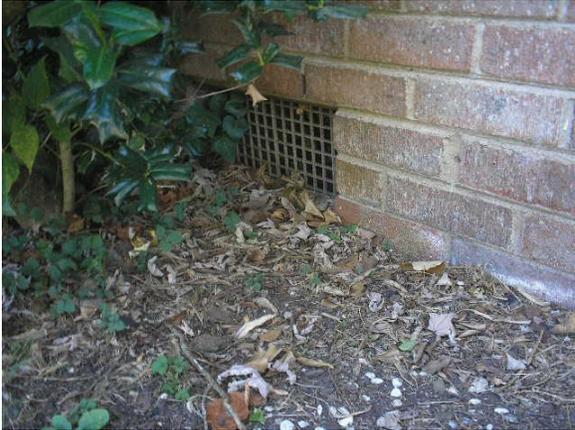
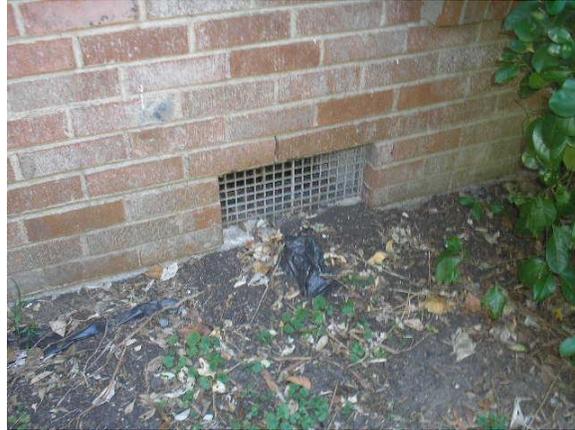
4.
5. Determining whether this home is in a flood plain is beyond the scope of my inspection.
6. This home is built on a relatively flat lot in a low area.

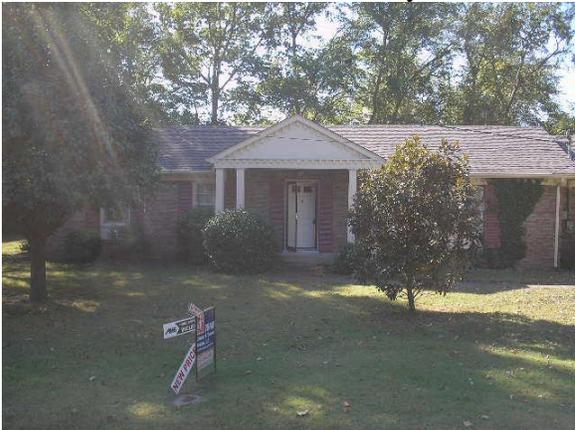
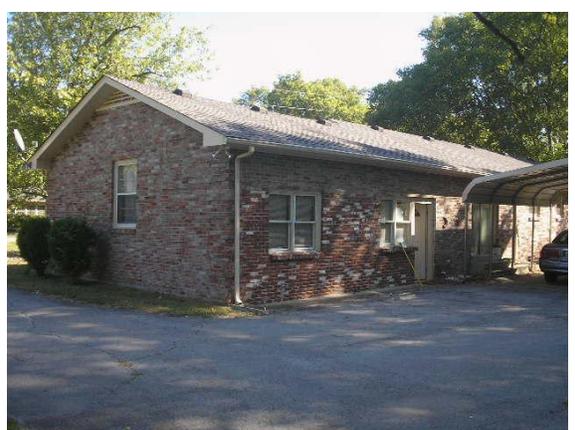
7.
8. The ground should slope away from the house continuously at least one inch per foot for ten feet minimum.
9. It is flat right up against the house in places on all four sides.
10. Building codes 401.3, 406.3.5 and 1806.5.5 require the ground surface to slope AWAY from the foundation 6" minimum drop in 10'-0" of horizontal distance. It is recommended that

11. Adding sloping compacted clay dirt up against house to any low lying areas around the foundation where ground settles will help kick water away from house. Do not cover any crawl space vents, weep holes in brick or bottom of siding (if applicable) with dirt or mulch. Half-circle wells are needed around crawl space vents.

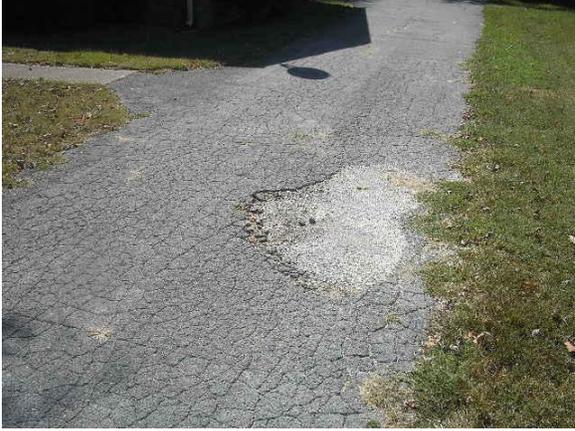
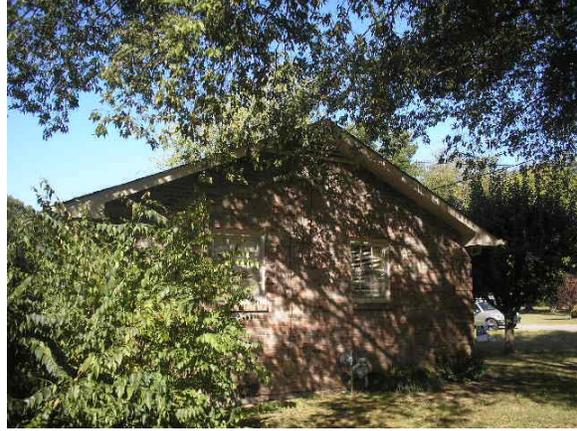
1. Asphalt driveway is cracked and is missing some asphalt in places.

- 2.
- 3. Some tree limbs are very close to the roof on the left end.
- 4. A lot of rotted wood and siding noted on the shed. Some may be termite damage too.

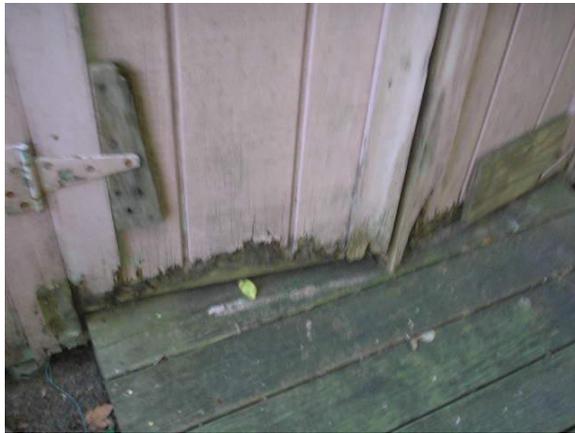
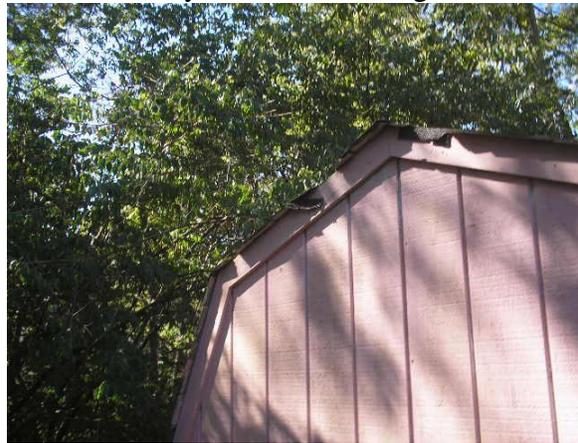
- 5.
- 6. Torn shingles noted on the shed.
- 7. Shed is locked, so I cannot inspect inside it.
- 8. Common cracking noted on concrete walks.
- 9. Ensure it is sealed off under the outside package HVAC unit and its metal shroud to help keep rodents out of crawl space. Use heavy screen wire outside and sheet metal in crawl space. No signs of rodents were seen in the crawl space at this time.
- 10. All shrubs should be trimmed at least 12" to 24" from the house to allow proper air circulation around the walls and HVAC units.

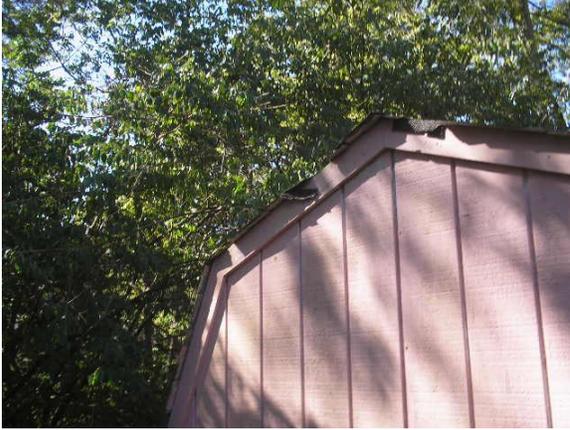
1. There was a hail storm in the area on April 7, 2006.
2. Some shingles are torn on the shed roof.

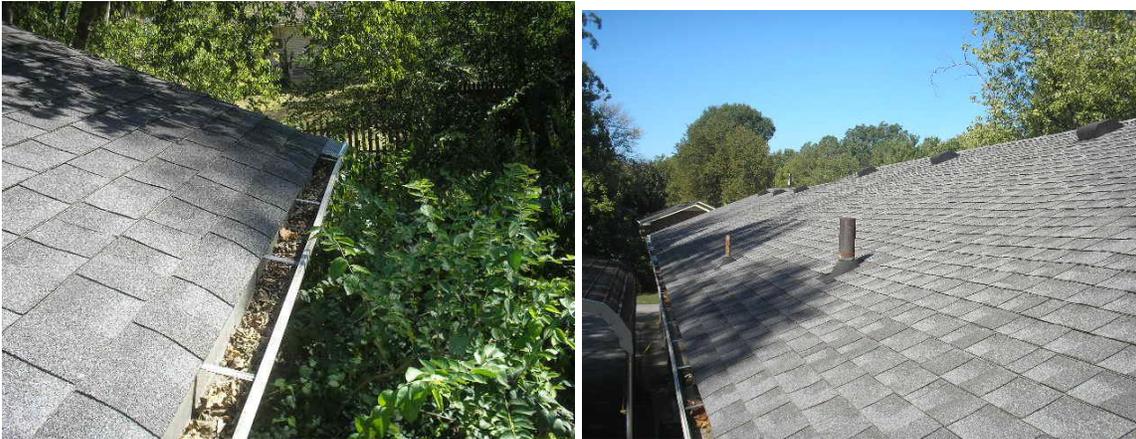
1. A lot of leaf guards are missing.

- 2.
3. Clean out gutters and downspouts.
4. Install leaf guards.
5. Gutters, downspouts and drains are often ignored. Poor maintenance on these items can cause more damage to house exteriors and foundations than possibly any other component. Gutters and downspouts should be cleaned at least once a year and kept in good condition to

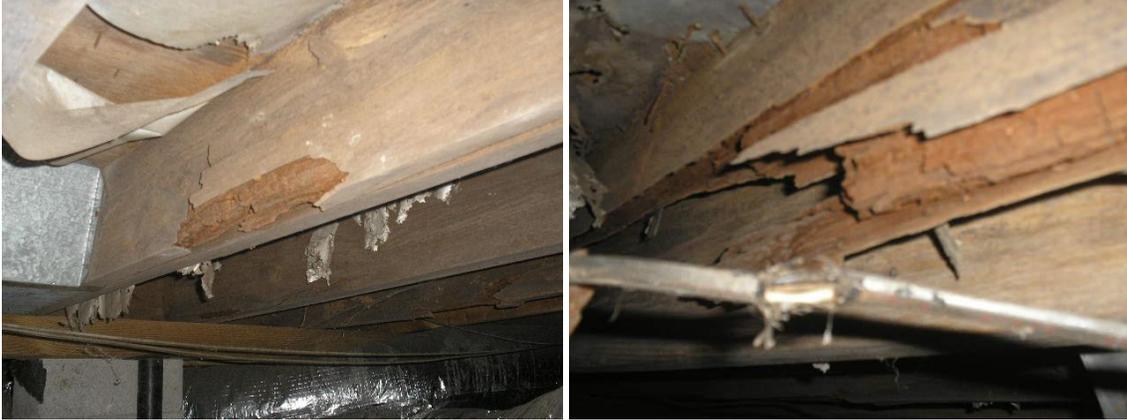
1. In the crawl space, many of the wood floor joists are severely deteriorated.

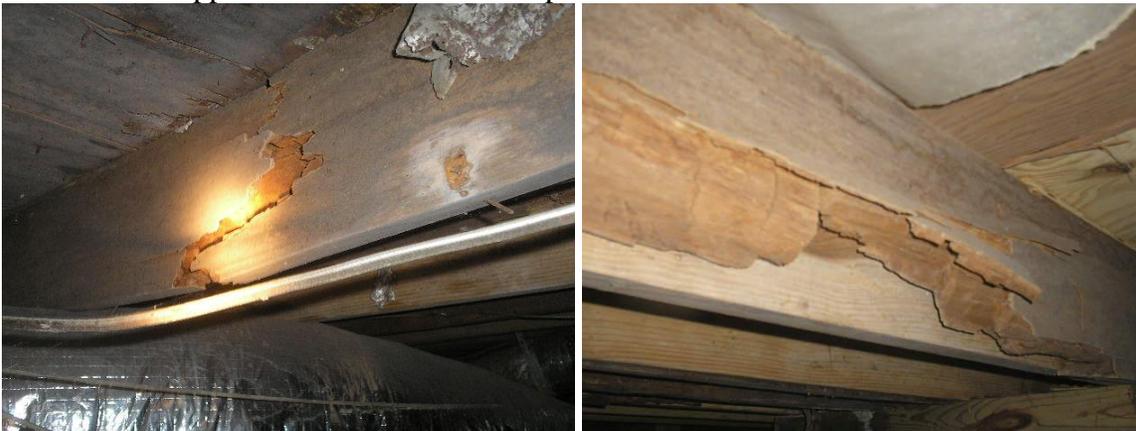
- 2.
3. Deterioration appears to be from moisture problems and lack of airflow.

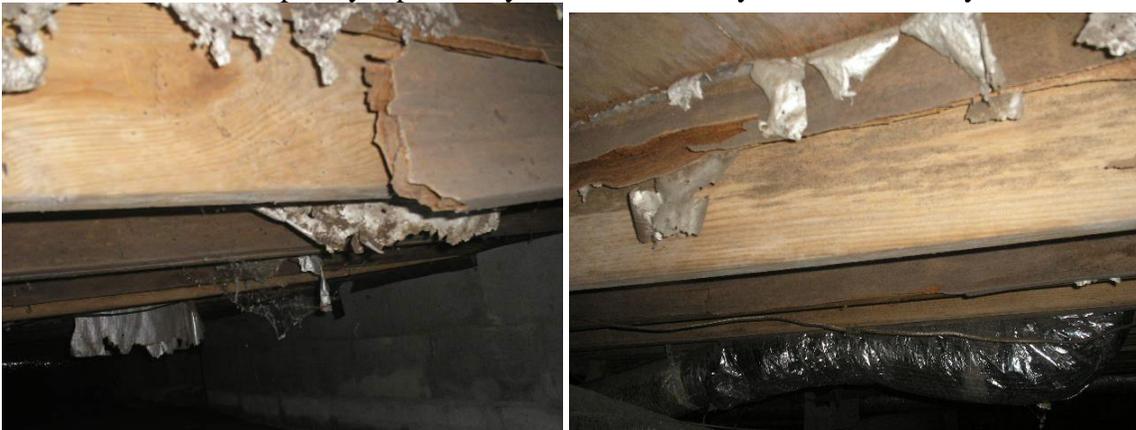
- 4.
5. Deterioration and temporary repairs may cause the floor system to fail at any time.

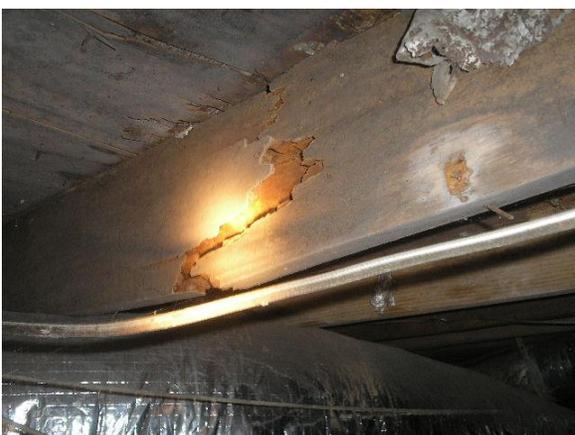
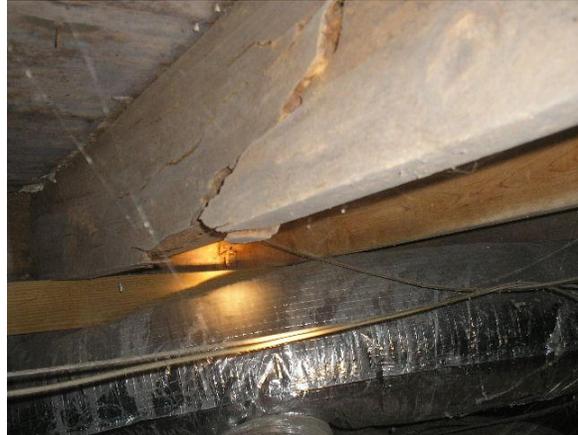
13. I can break some of the deteriorated wood floor joists in two with my bare hands.

14. Some of the wood floor joists are already broken in two.

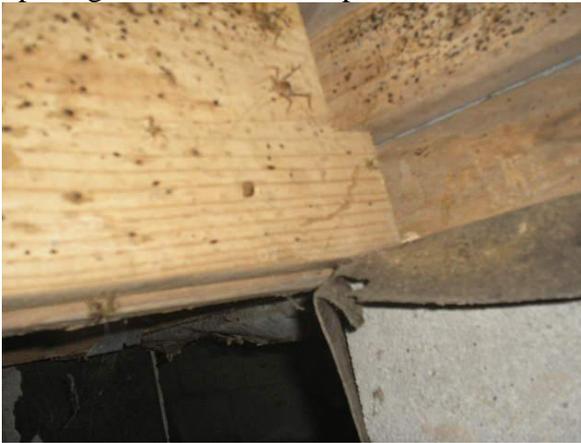
- 21.
22. Some new joist ends are not bearing on 2x2 ledger strips at all and some are attached with metal joist hangers with only one nail in them.
23. Simpson joist hangers should have a Simpson nail in every hole of the metal joist hanger per the manufacturer and engineer.
24. End of some new floors are about to slide off the edge of the concrete block wall near the opening to under the front porch.

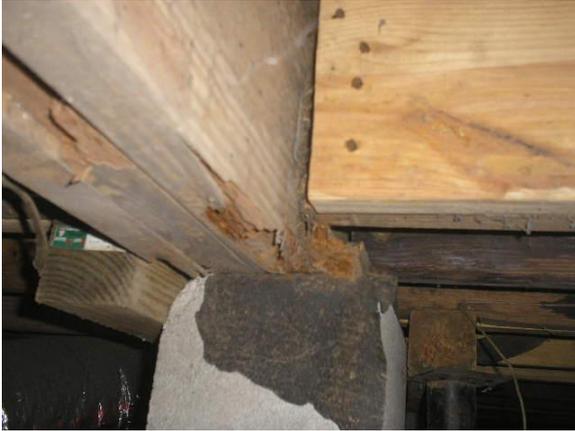
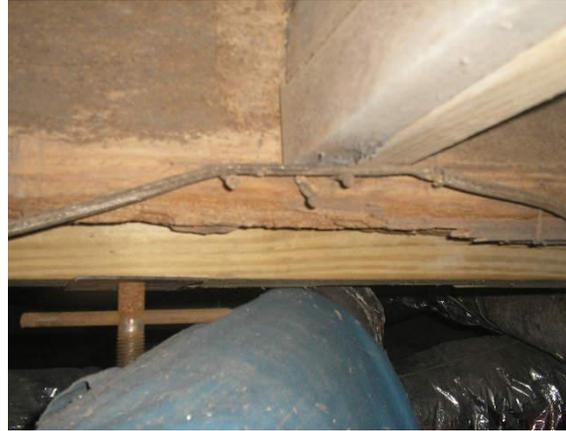
- 25.
26. Many deteriorated floor joists still need a new floor joist added next to them.
27. Some new floor joists are just toe-nailed into the beam without any support under their ends. This is not allowed by codes.

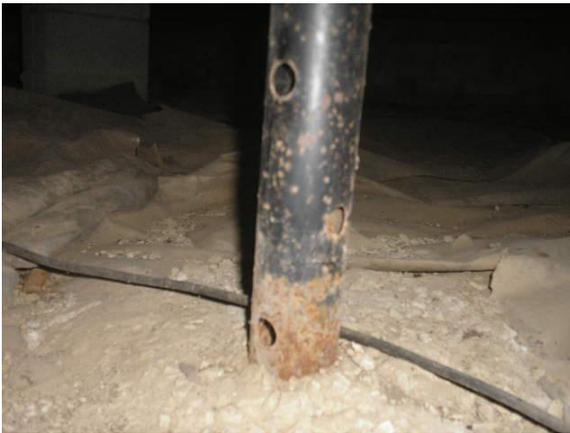
- 34.
- 35. Many temporary adjustable steel jack posts have been added. There are seven seen from where you enter the crawl space.
- 36. Some beams are held up by adjustable steel jack posts, but are not fastened.
- 37.
- 38. Some steel posts are rusted near the ground where it appears water may have been up around them.

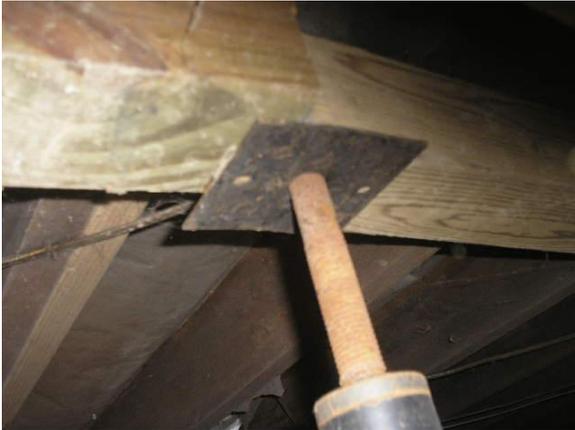
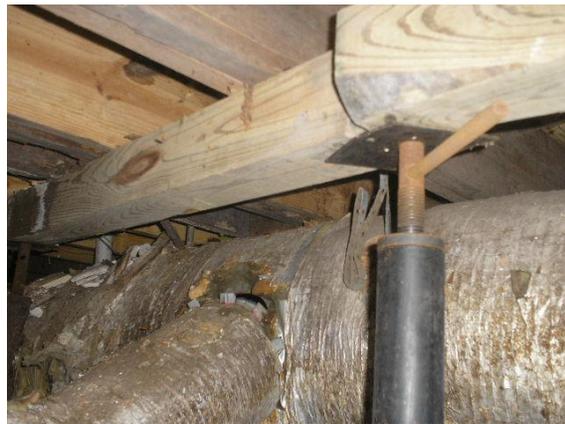
- 39.
- 40. Posts are not fastened to the 4x4 beams.

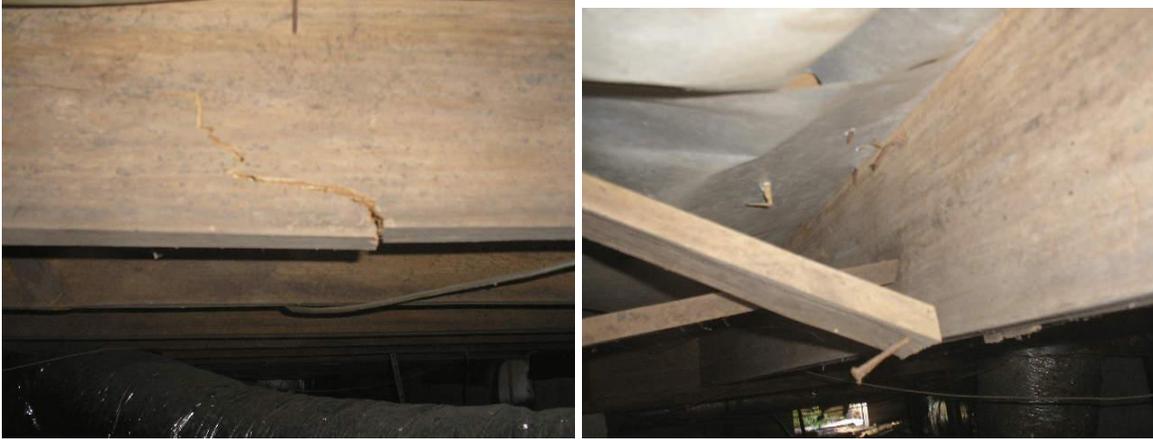
- 41.
- 42. A floor joist is broken in two under the front left bedroom. The joist next to it is cracked. This is where the 1x4 X-bracing is not nailed in place.

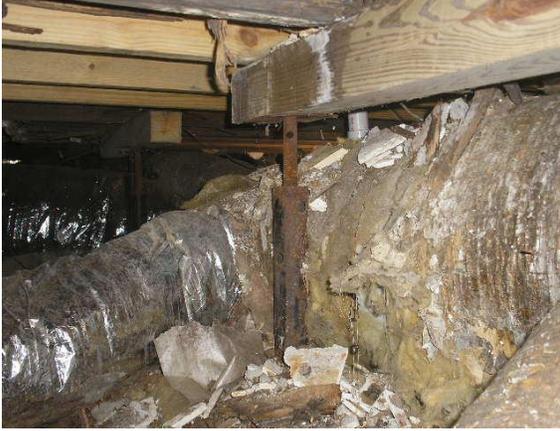
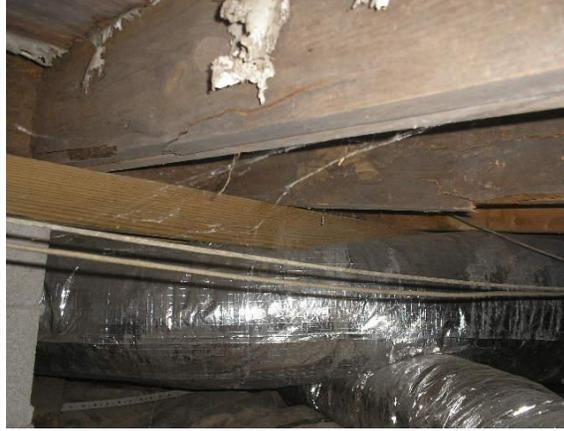
- 50.
51. Water stains noted on 4x4 beams.

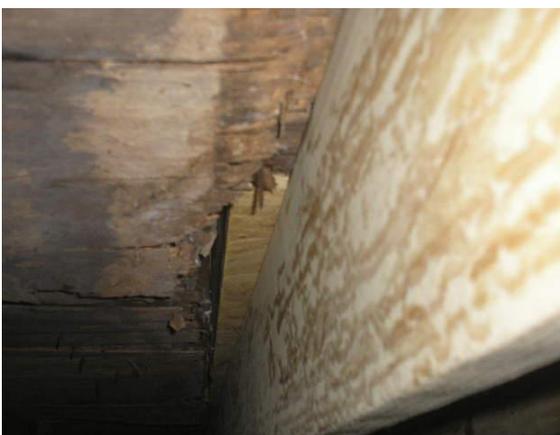
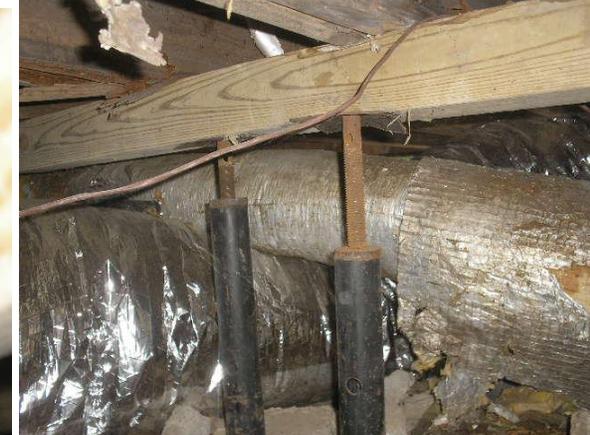
- 52.
- 53. Wood sub-flooring is rotted out and delaminated in some areas too.

- 54.
- 55. A structural framing repair contractor needs to make the repairs needed in a permanent manor and signed off by a registered PE (professional engineer) after permanent repairs are made.
- 56. Adjustable steel jack posts are NOT permanent.
- 57. Waviness noted in the roof.

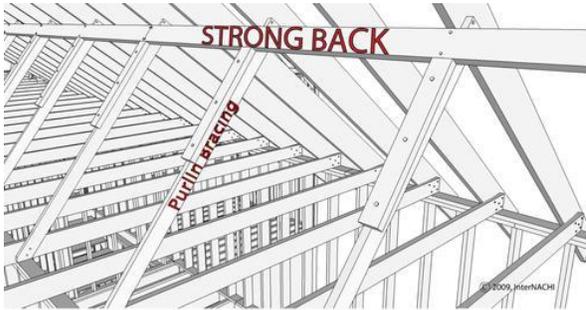
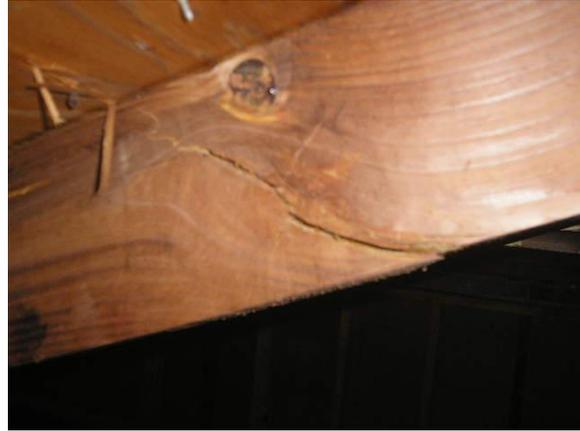
- 58.
- 59. Some 2x6 wood roof rafters are sagged in the middle, and at least one is broken. Mid-span supports are often added to help eliminate this.

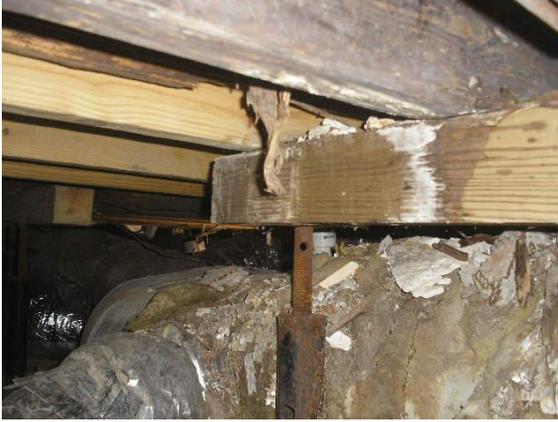
1. There appears to be a leak under the kitchen area. Water stains are run down the 4x4 beam below it.

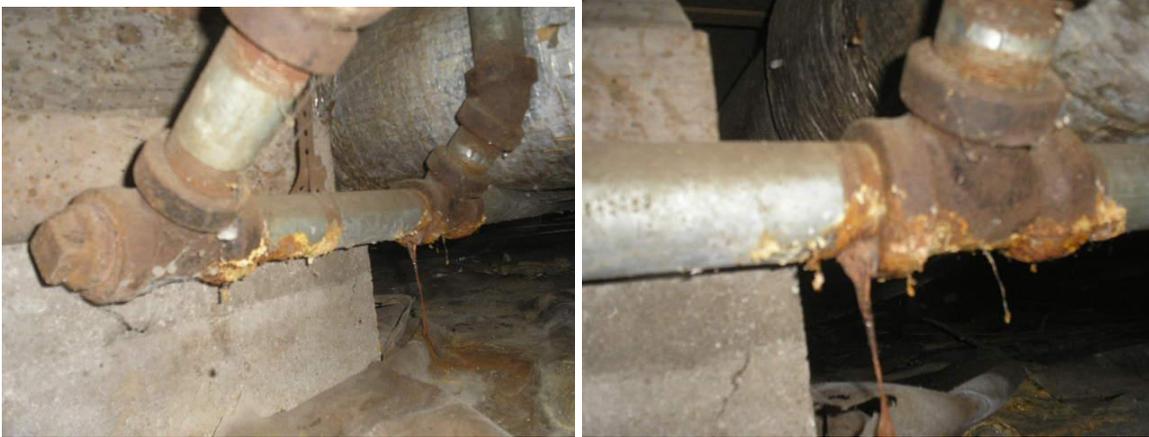
- 2.
3. The cast iron drain lines under the kitchen area are rusted badly in the center of the crawl space, and have leaked. They could rupture at any time. They should be replaced with modern PVC drain lines.

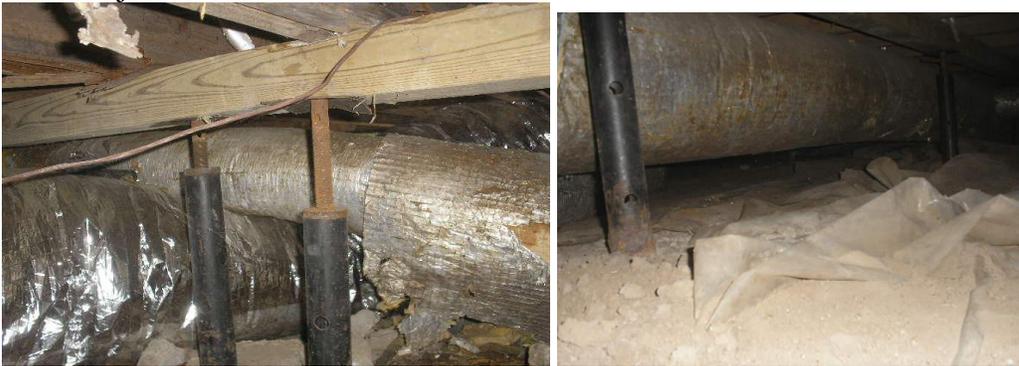
- 15.
16. Someone has tried to crawl over the ductwork and has damaged some ductwork and pulled one section off. Metal ductwork is only a few inches off the ground and is tight up against the floor joists.

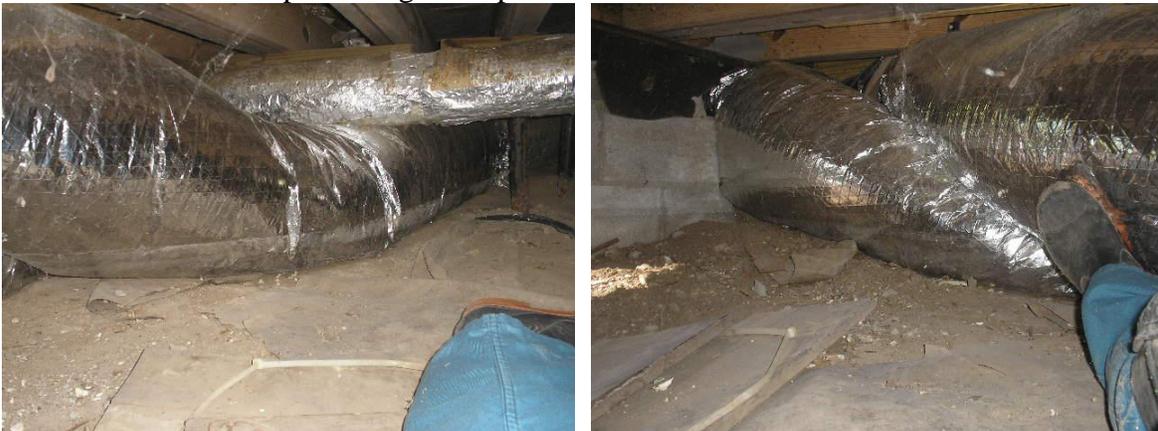
- 3.
4. Any ductwork that was in flood waters needs to be replaced due to contamination. City of Franklin usually requires this.
5. HVAC unit and other ductwork needs to be cleaned or replaced as directed by a professional.
6. The outside package hvac unit is higher than the crawl space ground, so it may not have been flooded. If it was flooded, it needs to be replaced as is usually required by the city of Franklin.
7. Ductwork should be up off the ground per codes.

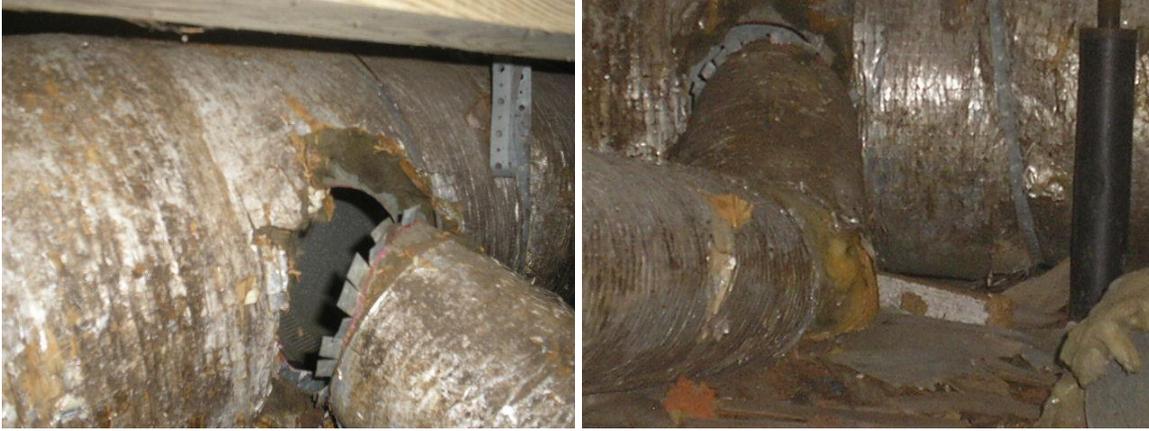
- 8.
9. In the center crawl space, a section of ductwork is pulled loose from the main trunk line that appears to run up to the living/dining room.

- 10.
11. Ductwork needs to be replaced.
12. Some of the insulation is torn off the ductwork and missing in the crawl space.

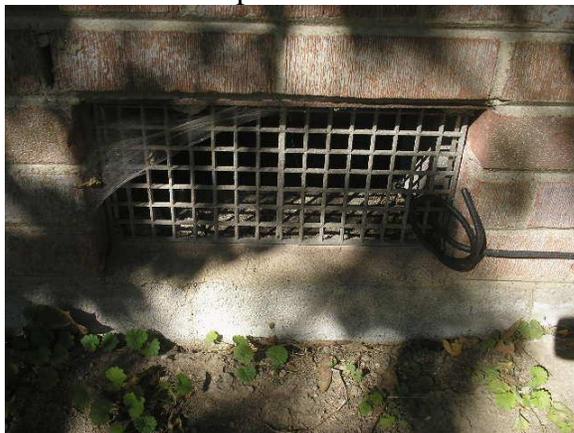
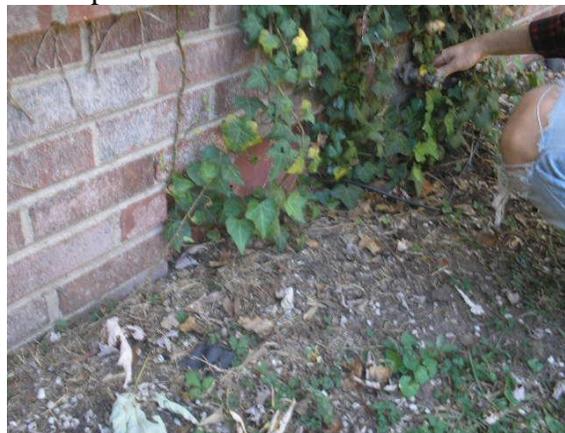
6.
7. Block walls appear to have water stains.
8. Install new crawl space vents with ones that can be opened and closed and have screens.

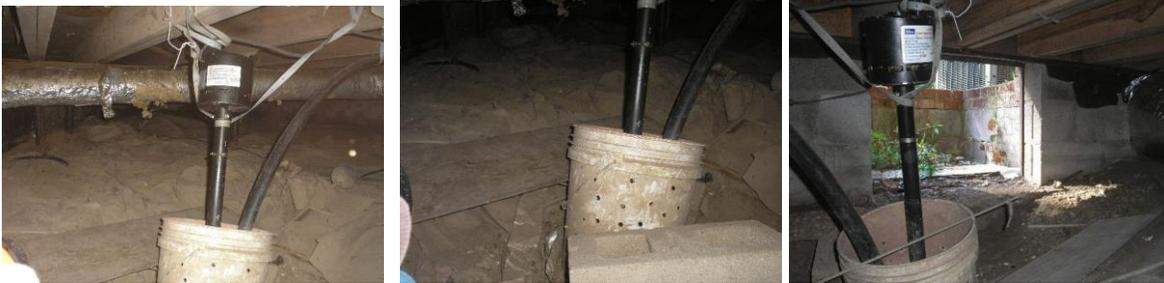
15.
 16. On the sump pump, the float arm is off, so it is not operating at this time.

17.
 18. Sump pit should be secured down into the ground.
 19. I only recommend a sump pump as a last resort, since they are noisy and not dependable.
 20. I prefer the drainage to be taken care of so water never enters the crawl space to begin with.
 21. It appears water has flowed in some crawl space vents as seen on block walls.
