**123 Any Lane, Brentwood, TN**

## **HOME INSPECTION REPORT**

Evaluation of property located at: **123 Any Lane, Brentwood, TN**

Time of the inspection is: **July 5, 2010 9:30 AM to 12:06 PM**

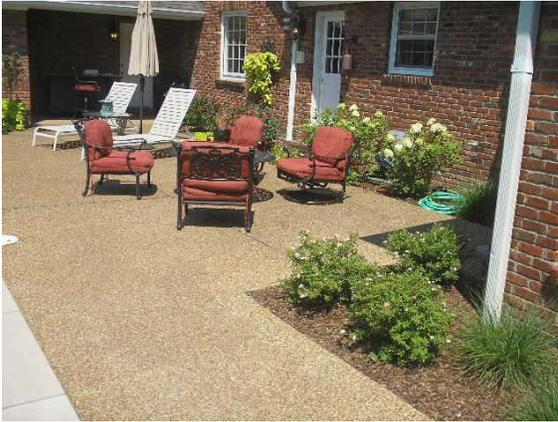
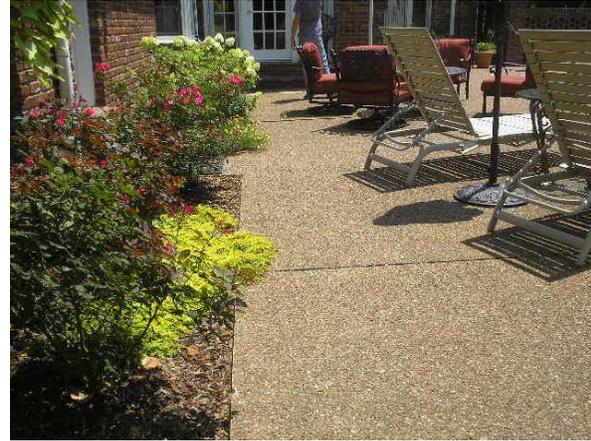
1. This home is built on a lot that is relatively up around the house.
2. The ground should slope away from the house continuously at least one inch per foot for ten feet minimum.
3. Concrete patio area drains toward the back of the house from the pool.

- 4.
5. It is flat right up against the house in places on all four sides.
6. Building codes 401.3, 406.3.5 and 1806.5.5 require the ground surface to slope AWAY from the foundation 6" minimum drop in 10'-0" of horizontal distance. It is recommended that the ground slopes away from the house at least 1" per foot for at least 10'-0".

7. Adding sloping compacted clay dirt up against house to any low lying areas around the foundation where ground settles, will help kick water away from house.

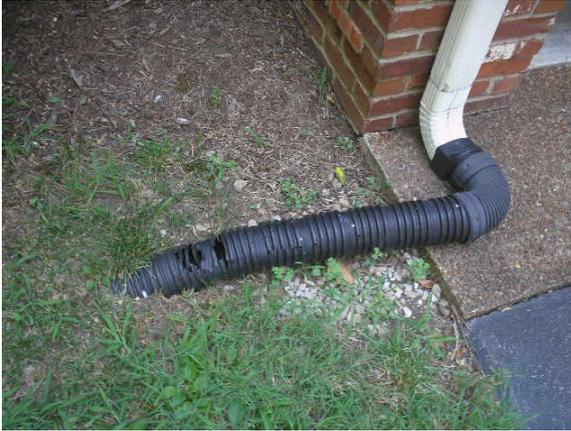
1. Downspout extension pipe has a lot of holes in it on the front right corner of the garage, making it ineffective in carrying the water away from the house. The concrete block wall inside the garage on this corner has a hairline crack in its mortar joints, which is probably due to water dumping out in this flat area by the house.

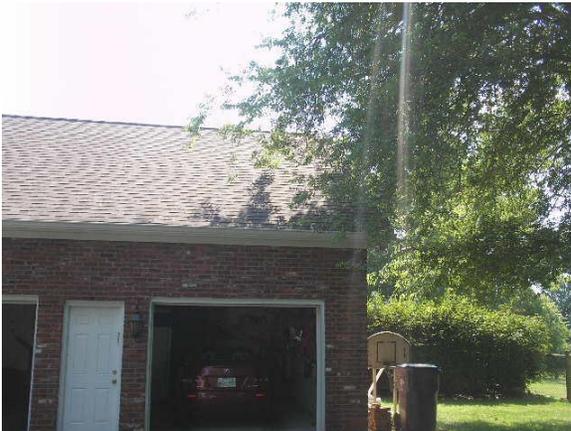
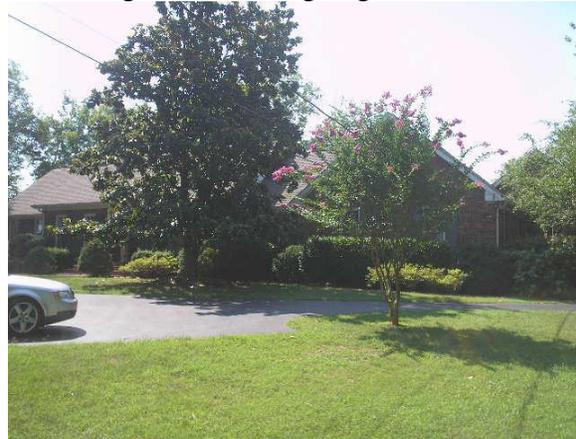
1. Some tree limbs are rubbing the roof; like on the rear right above the garage and front.

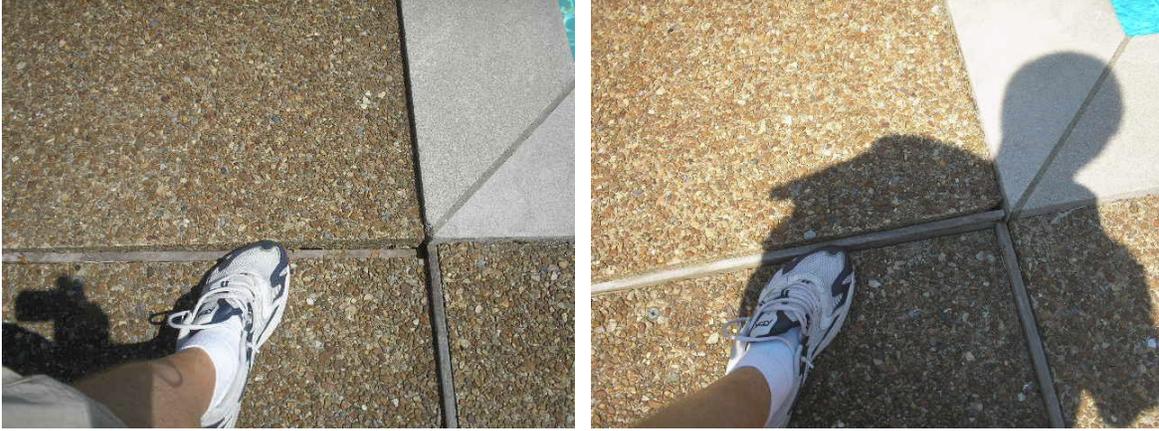
- 2.
3. Tree limbs are also rubbing the overhead electric service wires, which are too low.
4. Trip hazards noted where the concrete pool decking is settled to different heights.

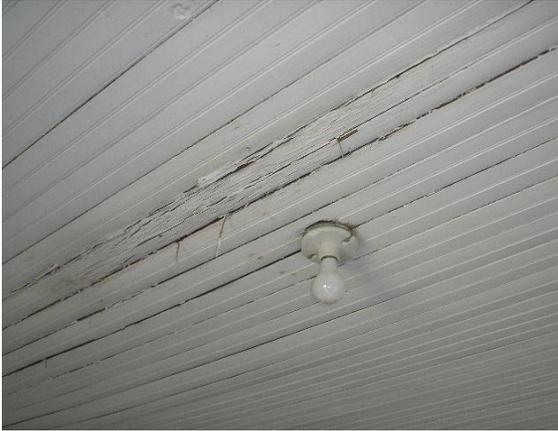
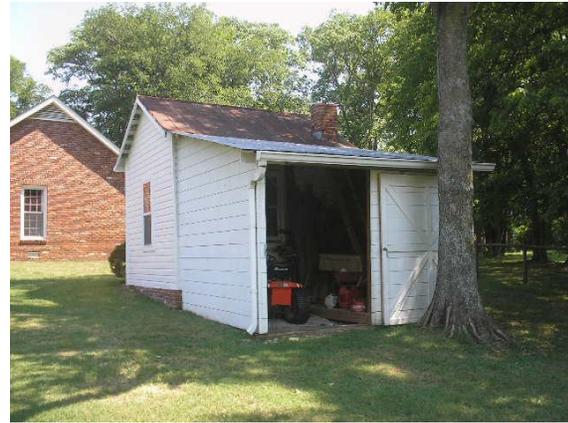
- 11.
12. Shed house shows there has been a roof leak. There is water damage on the bead board ceiling inside.

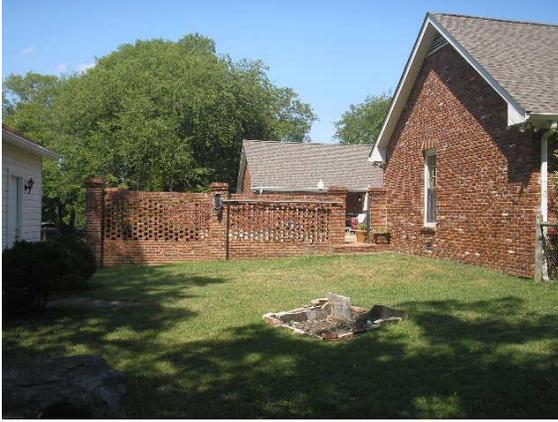
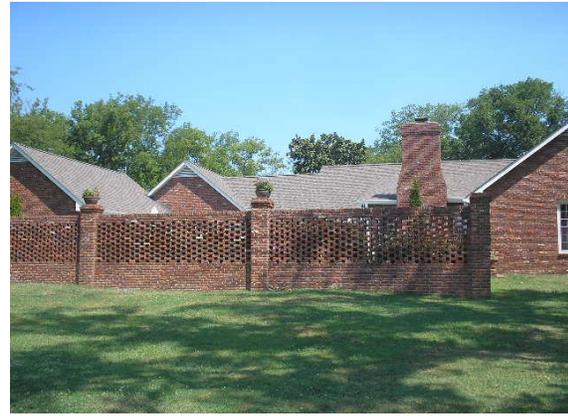
- 17.
18. Doors and gates from the house into the pool area need pool alarms and proper locks on them.
19. Pool fence is climbable by a child. It has open holes in it. It is not child proof.

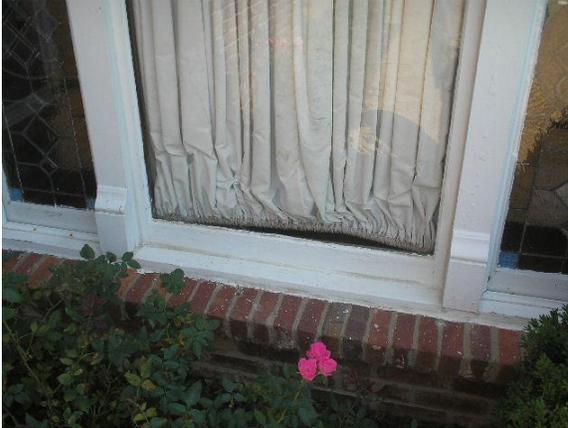
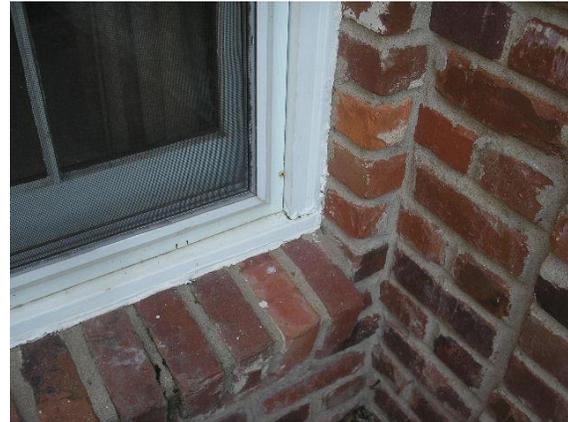
1. There is some paint peeling off with bare wood showing on the outside of the master bedroom stained glass window frames.

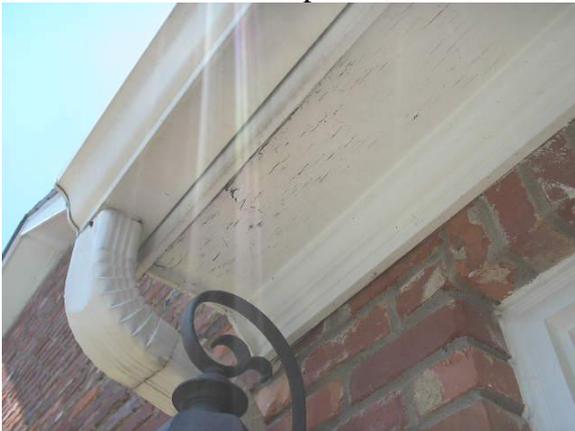
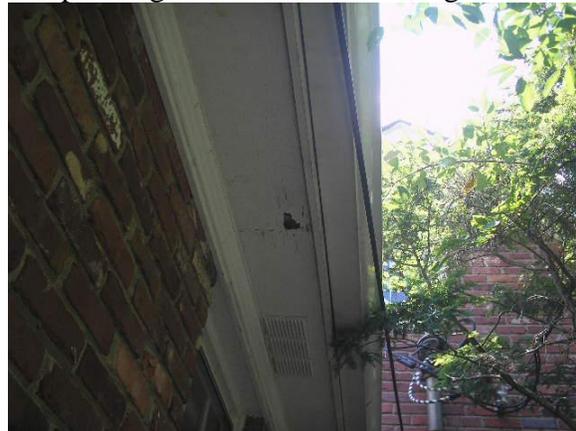
- 6.
- 7. Soffit is rotted in a few places; like above the rear patio light from the kitchen, right side,

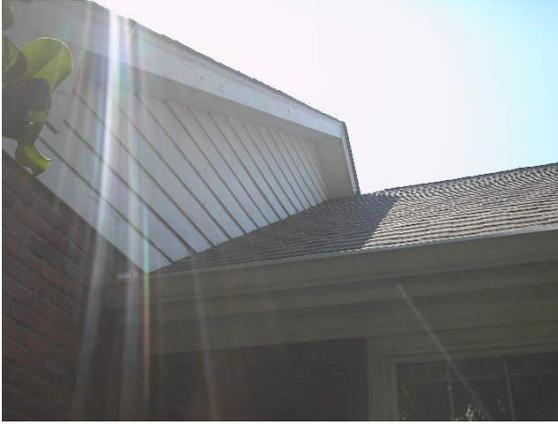
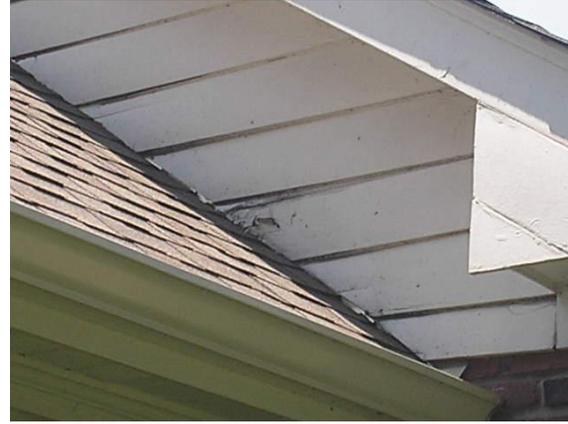
- 8.
- 9. There is a leak through the soffit above the right outside HVAC unit. There is some rotted wood here. Fix leak. Gutter may have overflowed.
- 10. Paint has come off some of the siding; like at the roof step up.

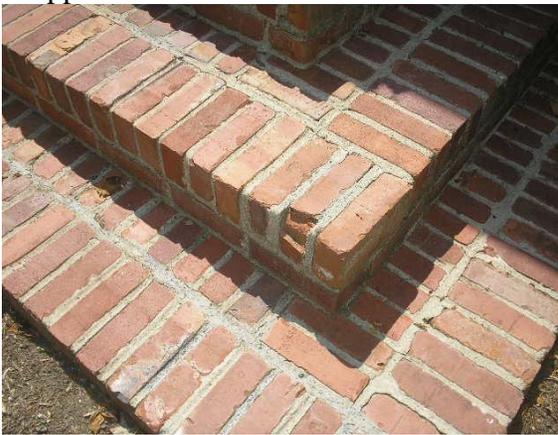
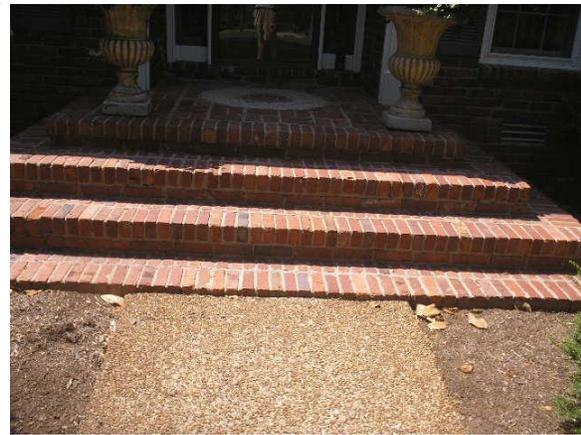
- 11.
12. Rotted wood siding noted on the front left side where the roof steps up.
13. Chipped and loose bricks noted in the front porch.

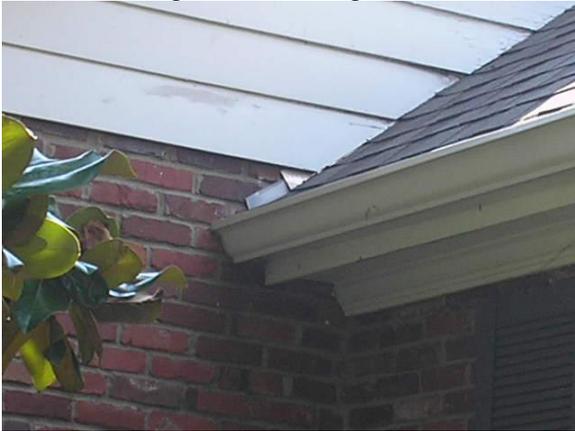
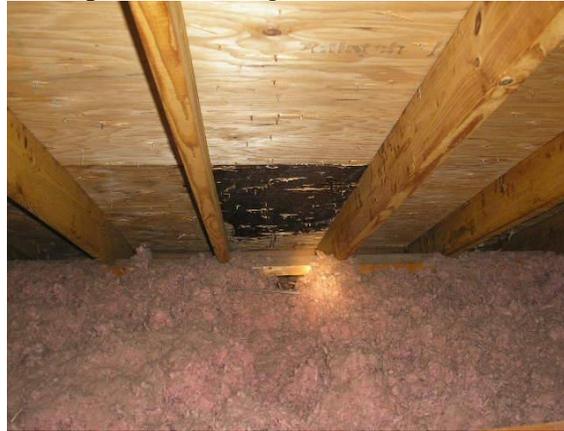
1. Shed shows signs of a roof leak. See LOT notes above.
2. Ensure leak through soffit above right hvac unit is not a roof leak as noted above.
3. Metal flashing needs sealing where it is not tucked up behind siding, like on front.

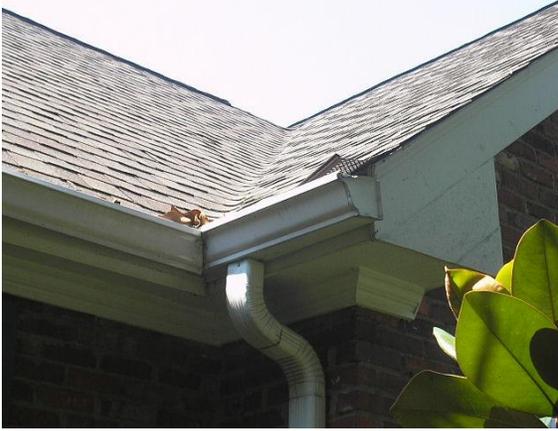
1. Some of the leaf guards are raised up off the gutters.

- 2.
3. Clean out gutters.
4. Install leaf guards better.
5. Gutters, downspouts and drains are often ignored. Poor maintenance on these items can cause more damage to house exteriors and foundations than possibly any other component. Gutters and downspouts should be cleaned at least once a year and kept in good condition to ensure the water flows through the gutters to the downspouts and well away from the house.

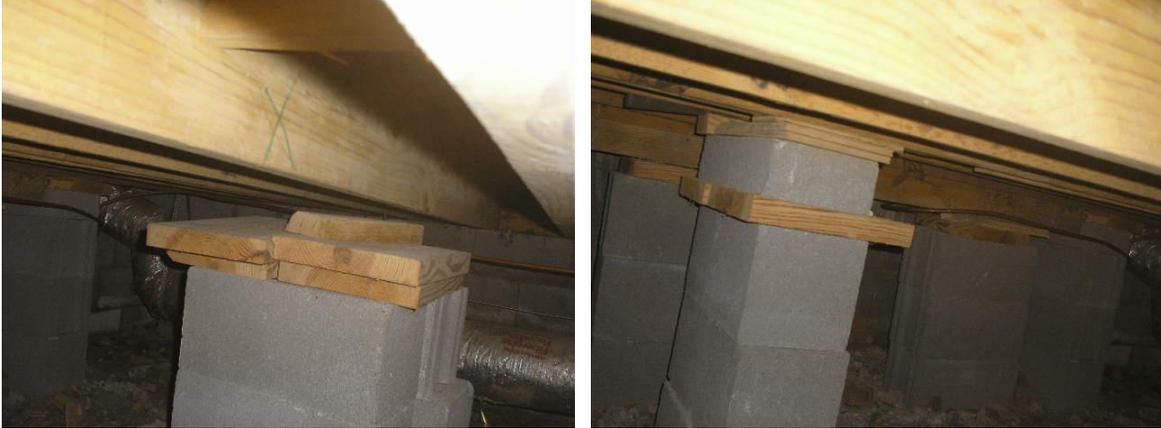
17. In the left crawl space, a wood floor joist is notched about half in two unnecessarily and has not been reinforced. Codes only allow a notch of 1/6 the depth of the joist. A 2x10 is 9.25" deep. So, a 1.54" max. deep notch is allowed. This notch is about 5" deep. Reinforce the heavily notched floor joist with a full depth joist of at least six feet long, nailed to it well in a staggered pattern.

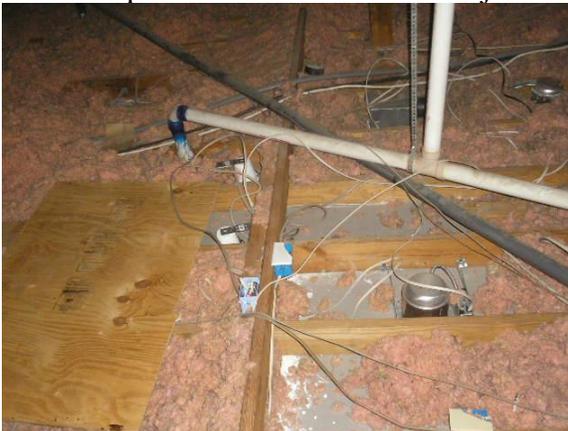
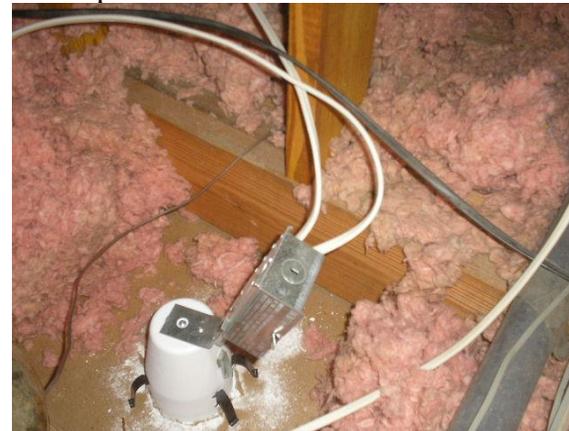
- 11.
12. There are some open electrical splices that need to be in covered junction boxes, like in the attic above the garage.
13. All wire splices should be in covered junction boxes per codes.

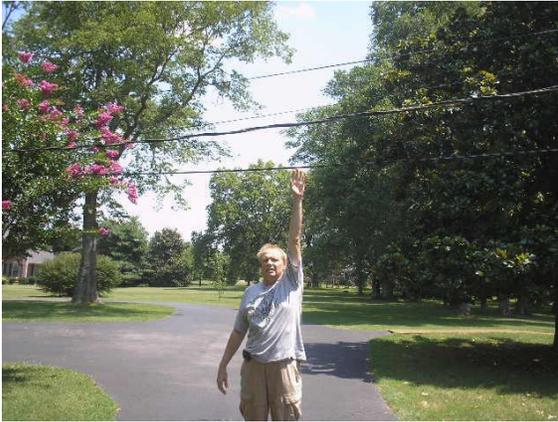
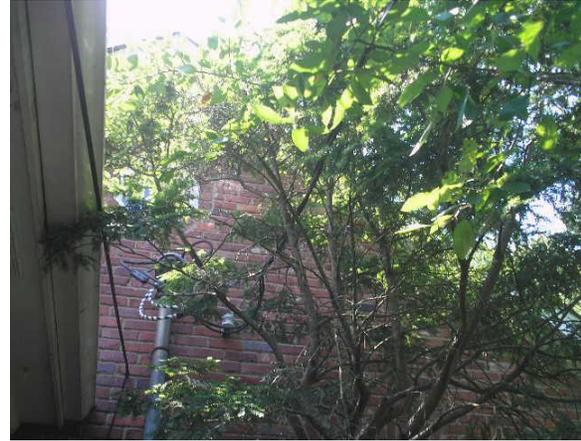
- 14.
15. Some electric wires are not stapled within 12" of the boxes in the attic either.
16. Cover plates are broken off some junction boxes on the attic floor.
17. The overhead power line is less than 9 feet above the driveway. Electrical code 230.24B2 requires electrical service drops to be at least 12 feet above driveways and ground. The utility company does not necessarily follow the rules in the NEC (National Electric Code), but they should. Check with your local jurisdiction and utility to find out what rules apply.

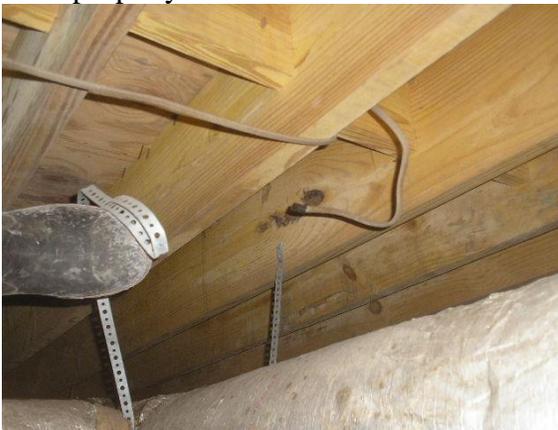
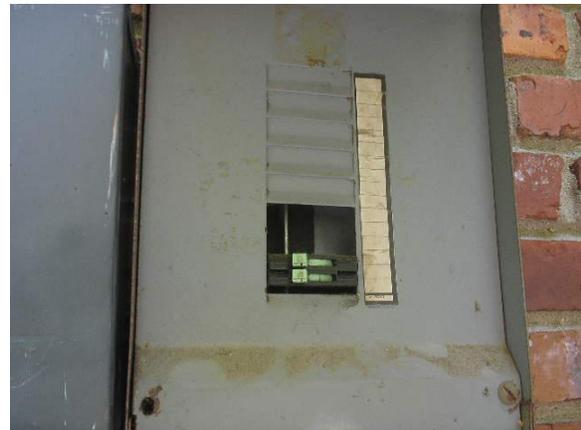
- 21.
- 22. In the center of the crawl space, there is an end of an electric wire hanging down that needs to be properly terminated.

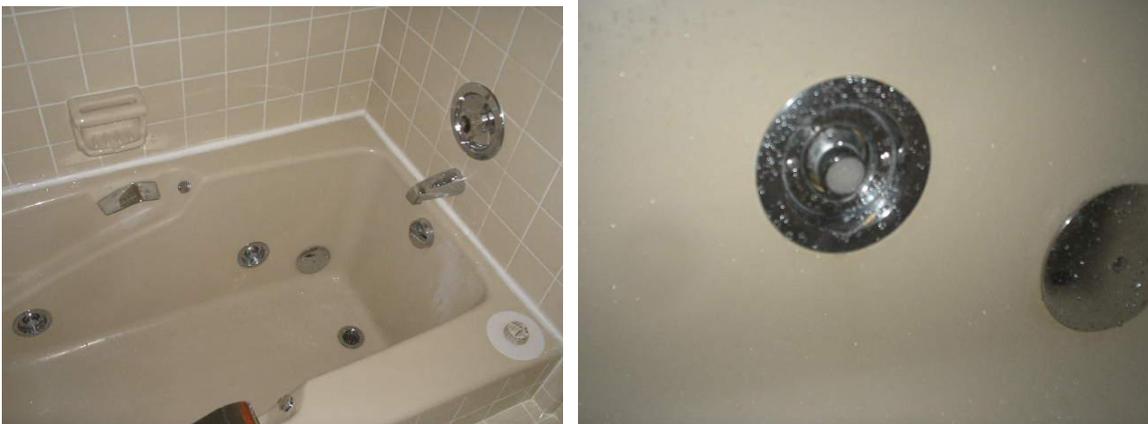
1. Master whirlpool tub does not work per sellers.

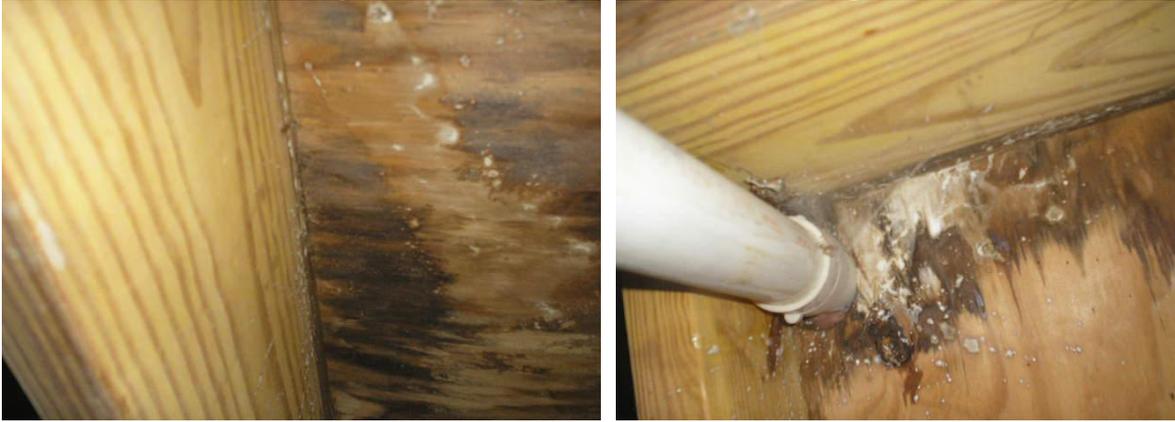
6. Floor is rotted under the right rear shower as seen from the crawl space.

11. At wet or rotted floors; fix leaks, remove any material with mold on them, treat area for mold, let it dry out completely, then repair/replace and reinforce wood flooring.

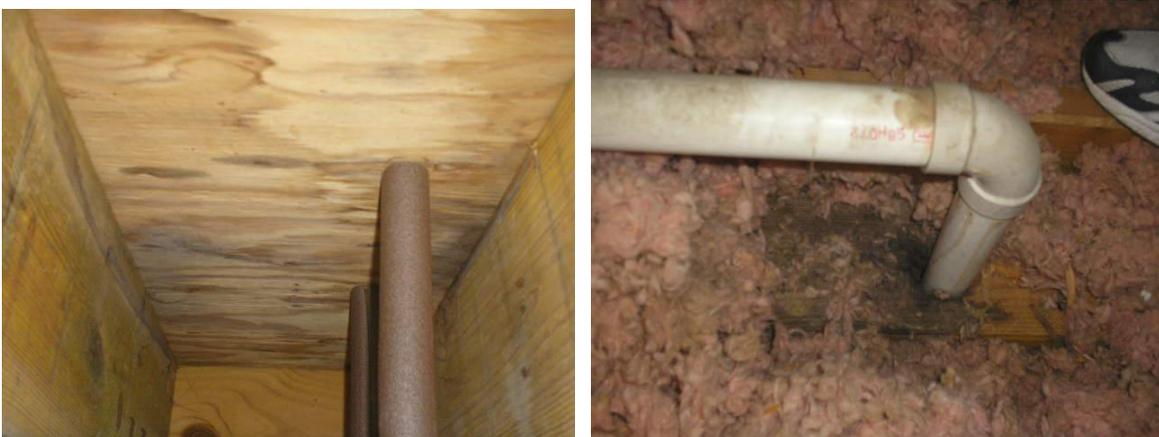
8. Floor has water stains on it where hot and cold copper water supply lines go up through floor from crawl space.

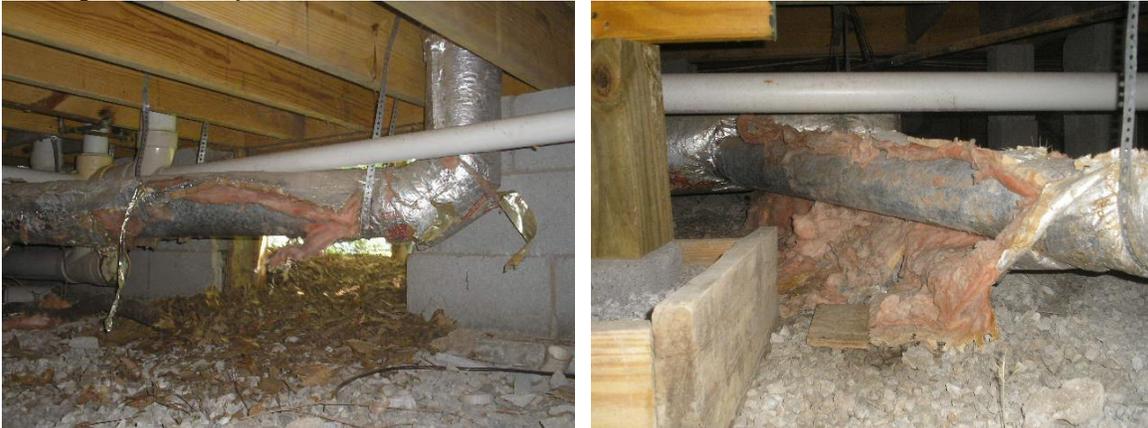
1. Throughout the crawl space, some insulation is torn off the ductwork by people having to crawl past it and by rodents.

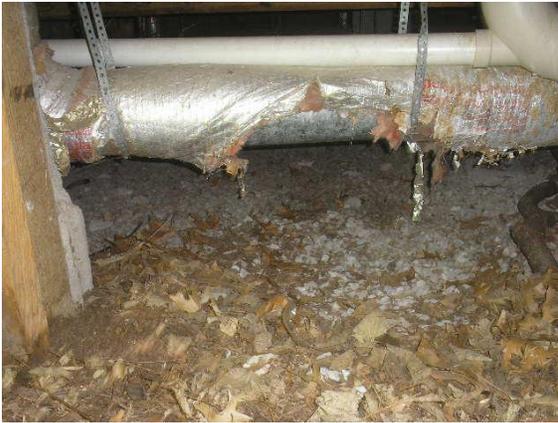
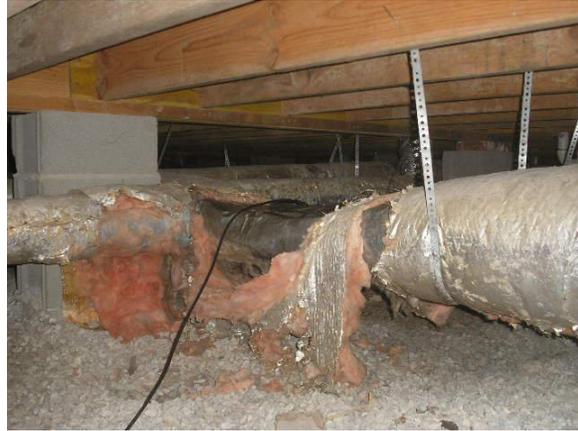
- 2.
3. In the crawl space, insulation torn off the ductwork like where you enter the crawl space from outside, under the kitchen,

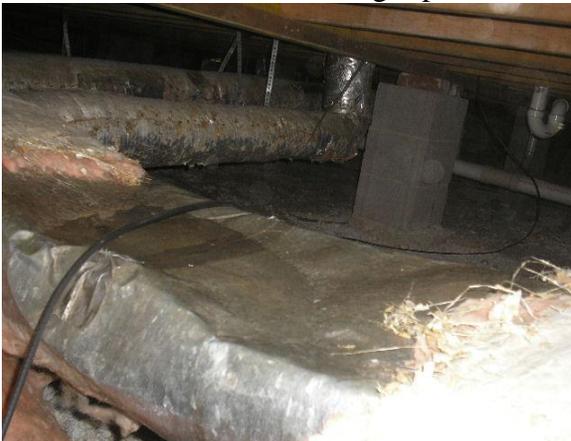
- 4.
- 5. In the left center crawl space, one metal duct is crushed and duct insulation is missing where someone crawled over it in right picture above.

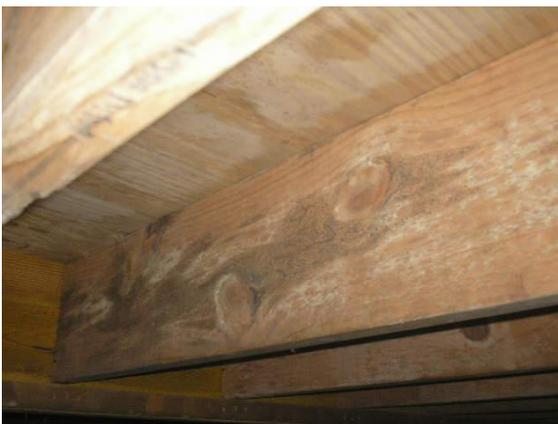
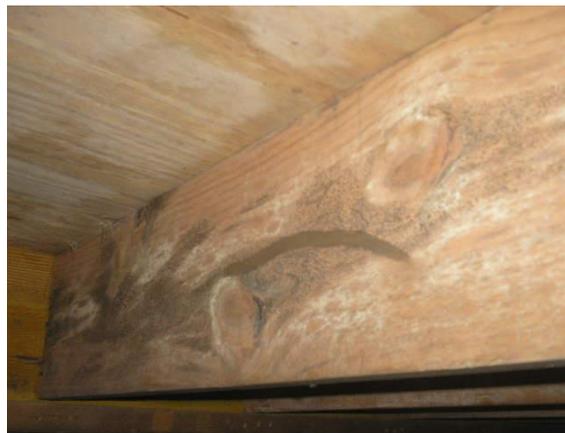
- 6.
- 7. There is water standing on this flattened duct from condensation, and there is black wet mold-like substance on the wood floor framing above it. Repair/replace crushed duct, insulate duct, clean off mold-like substance and treat area for mold. Picture below shows before and after I wiped my finger through the mold-like substance above the water standing on top of the crushed ductwork.

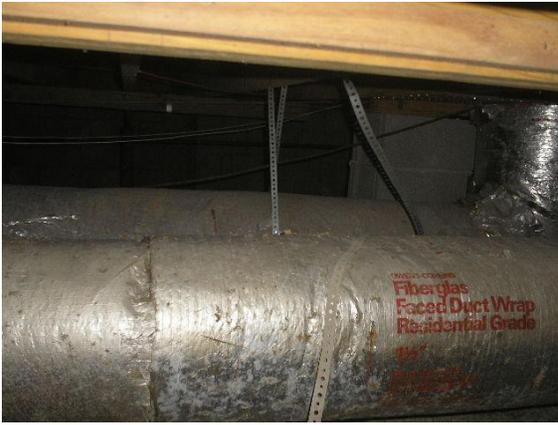
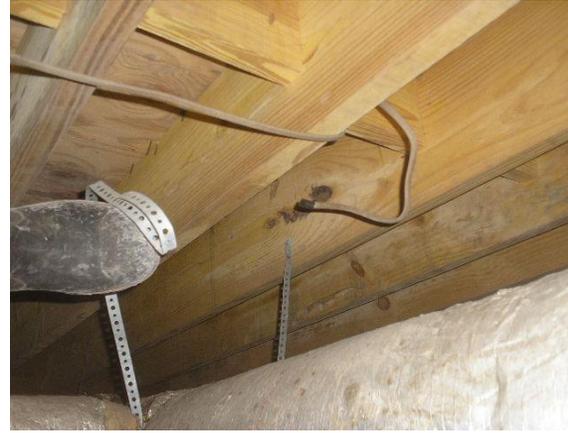
- 13.
14. In the crawl space, there is a floor air vent cut through the sub-flooring it appears to be under the kitchen cabinets that is not sealed over. There are lots of spider webs over it. The right picture above is looking up into the base of the cabinet through the unused rectangular duct hole through the floor. Seal it off airtight since it is not being used.
15. Some straps are off the ductwork in the crawl space by someone crawling over them. The right picture below is my boot holding up one loose strap for the picture.

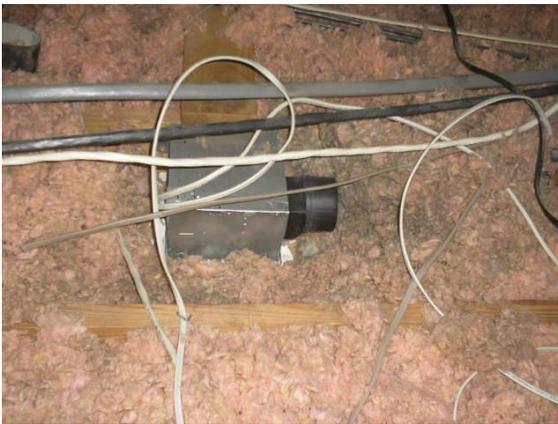
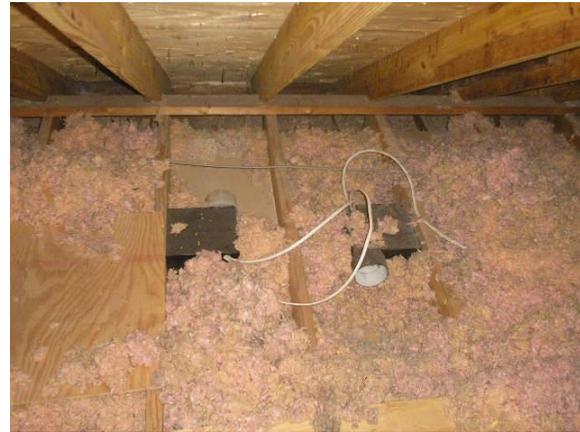
22. Undercutting the interior doors will improve airflow, when doors are closed.
23. Bath exhaust fans are just vented into the attics instead of to the outside as they should be. There is not much insulation around them.

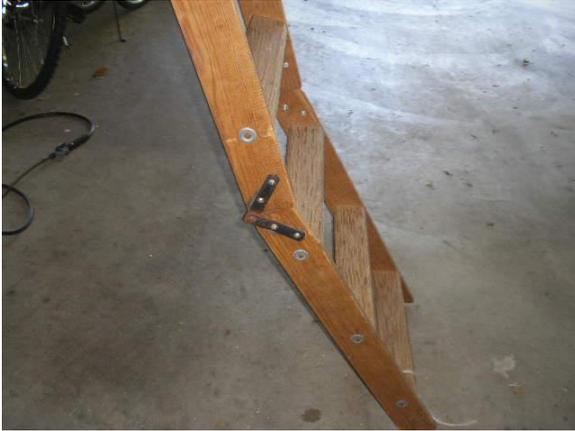
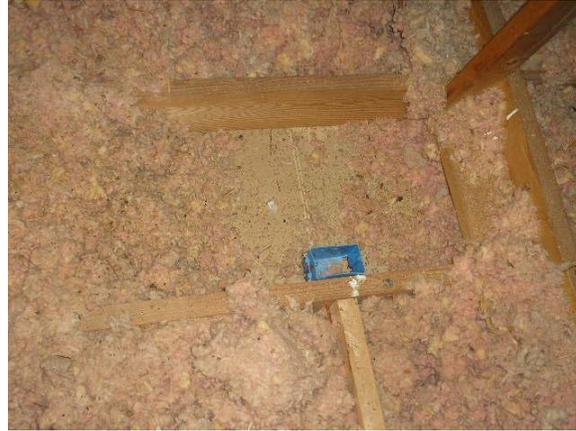
1. The pull-down attic stairs are unsafe. They are missing proper fasteners in the open holes in both main metal side spring arm pivot plates. The WARNING label on the stairs usually calls for  $\frac{1}{4}$ " x 3" long lag screws or 16d nails through the spring arm pivot plates, the corner brackets at the main header hinge, the opposite frame member and both side lengths of the frame. The use of sheetrock screws or finish nails are prohibited and can cause the stairway to suddenly fall from the opening possible causing bodily injury.
2. The pull-down attic stairs are bowed back and wobbly.
3. The pull down stair legs open out to an odd angle causing some stair treads to be unlevel and unsafe. Also, tighten all nuts, bolts and screws. This is a fall hazard!

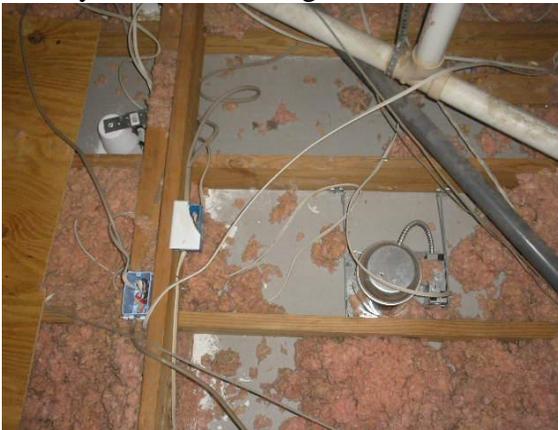
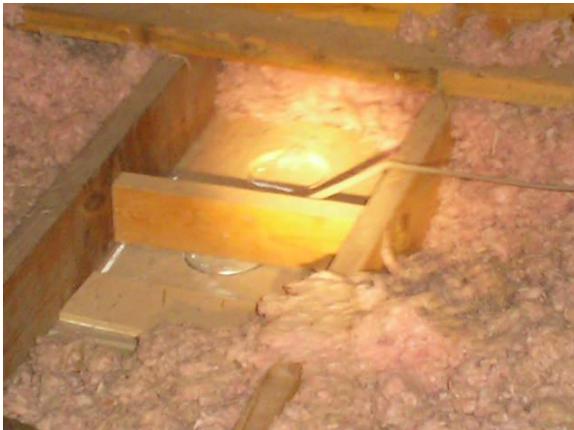
- 4.
- 5. Insulation is missing in spots in attic. This can explain the warm areas felt in the rooms when you walked through earlier.

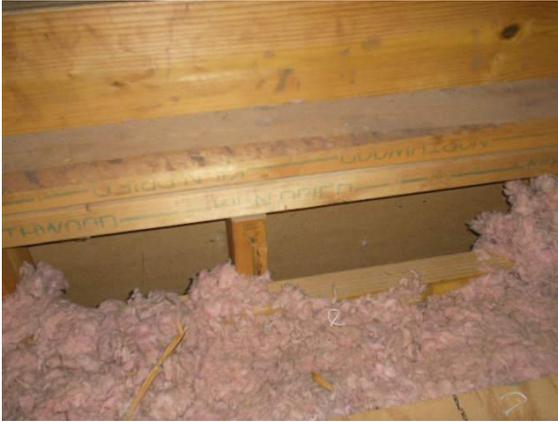
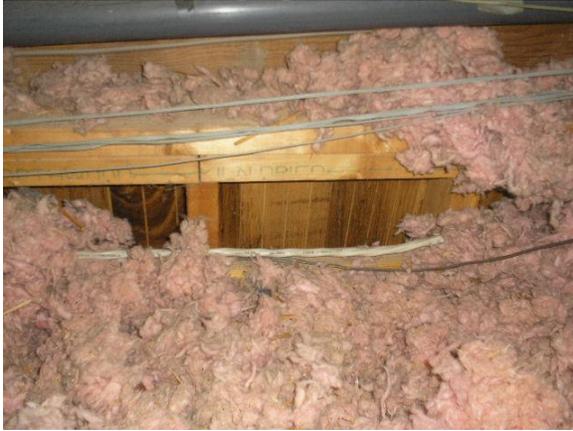
11.   
 12. There are some water stains on the wood framing where a PVC pipe goes through the ceiling in the rear left attic above the master. See PLUMBING notes above. Joint is not glued well on the sewer vent pipe in the rear left attic where it has leaked onto the attic floor.   
 13. There are some daylight gaps showing where wasps can enter the attic along the eaves.   
 14. There is no insulation on some of the short walls where they step-up in the attic.

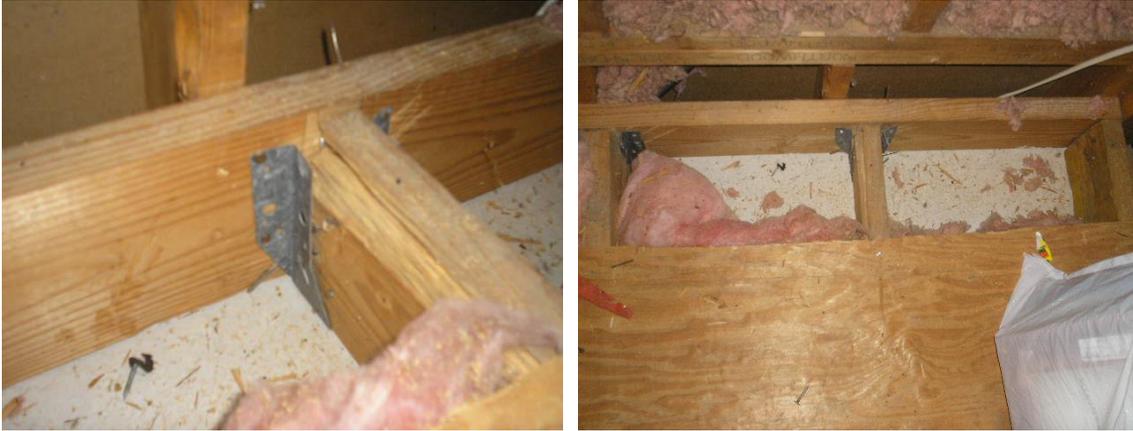
17.   
 18. Some nails are missing in metal joist hangers in the center attic floor framing. Every hole in the metal joist hangers should have a nail in it.

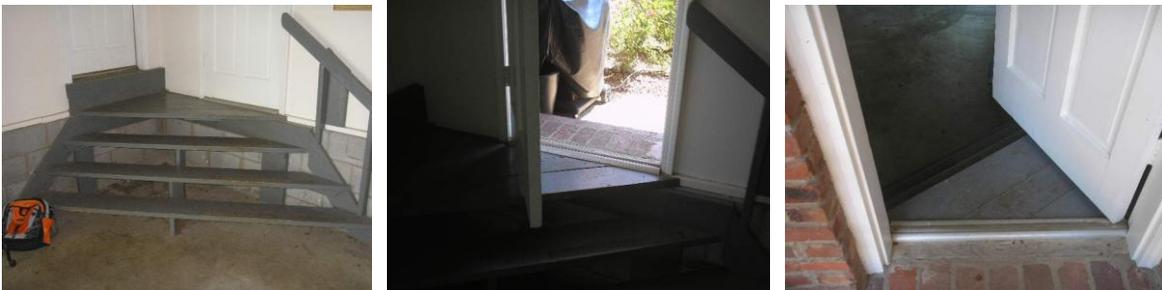
1. Drywall mud was over the electric panels. Per codes, the electric panels in the garage need to be readily accessible and easily removed. I did my best to cut out around the drywall mud, but some of it came off. This needs to be redone properly.
2. Door swinging into the garage from the patio does not have a landing in the garage. This door swings right out over the stairs. If you're coming from the patio, you step immediately onto the stairs. This is a code violation and is unsafe.

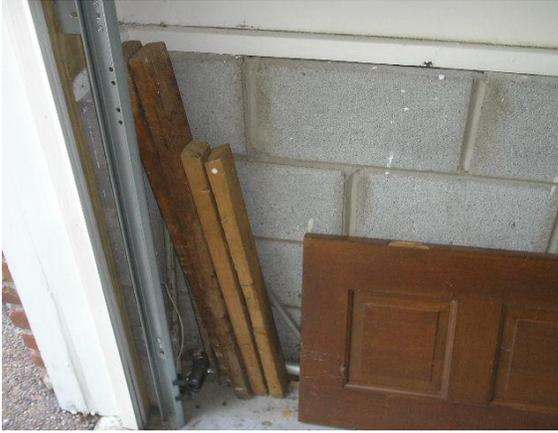
- 3.
4. Wood steps in garage are loose and are different heights. They should not be more than 3/8" difference in height.
5. Common hairline crack noted in the block foundation wall at the front right corner.

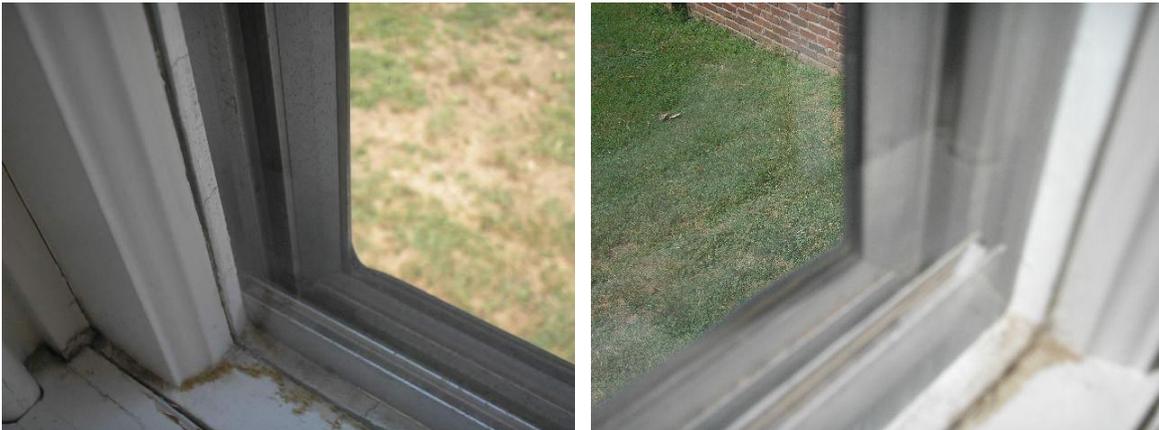
1. Some doors to the outside have the type of lock that makes it easy to lock yourself out. They feel unlocked inside when they are actually locked outside.
2. Doors and gates from the house into the pool area need pool alarms and proper locks on them.
3. Some of the plastic tabs are broken off the top sides of the storm windows; like in the master bedroom.

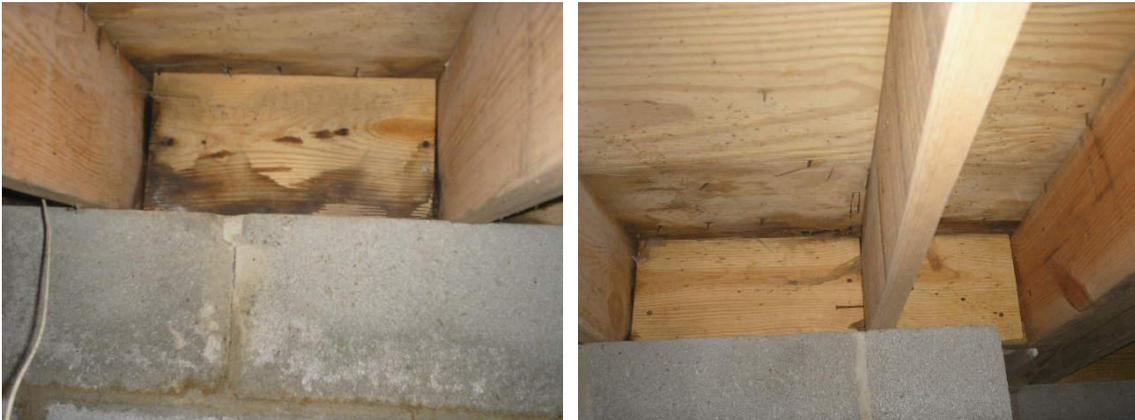
- 8.
9. Floor is rotted out under the master tub. Ensure this leak has been fixed and reinforce under the tub.
10. In the left center crawl space, some insulation has come off the ductwork, and some is crushed where someone has crawled across it. There is water standing on it from condensation, and there is black mold-like substance on the flooring above it. See HVAC notes above.
11. The wood rim joist is rotted out under the door going out to the patio from the living room.

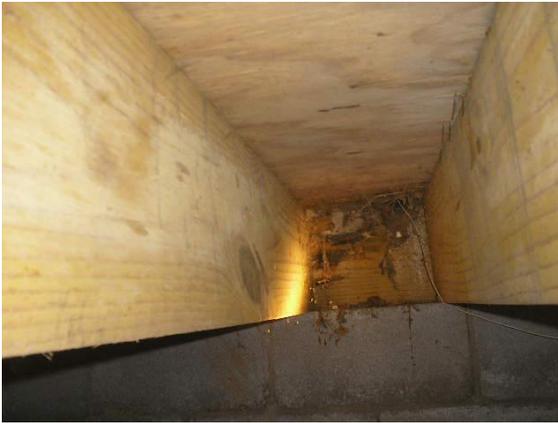
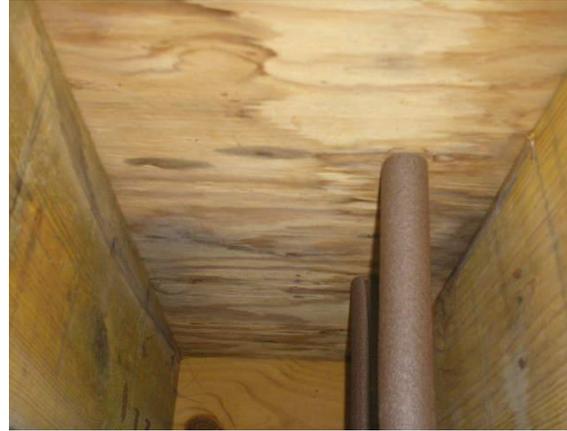
- 12.
13. There are water stains and rot on the flooring under the rear right bath and master bath. Ensure leaks are fixed. Treat for mold. Reinforce floor.
14. Common dampness on ground and concrete block walls around the perimeter foundation walls in the crawl space.
15. Improve the exterior drainage to eliminate dampness in the crawl space as noted under LOT DRAINAGE notes at the beginning of this report.
16. Some drainage contractors add a French drain along the perimeter foundation walls either inside or outside of the crawl space.
17. There are a lot of wood scraps, cardboard and debris on the ground under the fireplace and kitchen. This is termite food.
