123 Any Drive, Franklin, TN

193 Heathersett Dr., Franklin, TN 37064 (615) 791-7433 Steve Traylor, owner/inspector

HOME INSPECTION REPORT

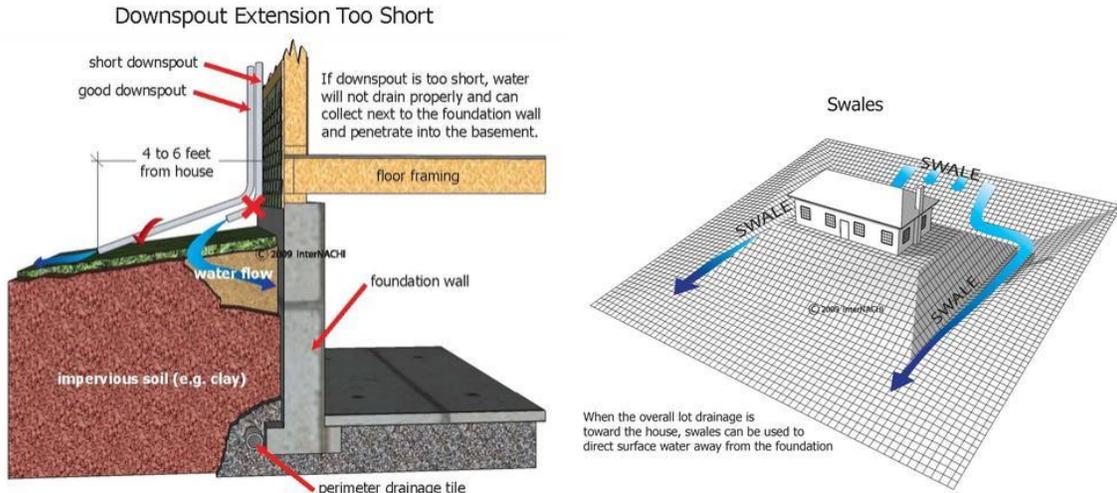
7.
8. The ground should slope away from the house continuously at least one inch per foot for ten feet minimum.
9. It is flat right up against the house in places on all four sides.
10. Building codes 401.3, 406.3.5 and 1806.5.5 require the ground surface to slope AWAY from the foundation 6" minimum drop in 10'-0" of horizontal distance. It is recommended that

11. Adding sloping compacted clay dirt up against house to any low lying areas around the foundation where ground settles will help kick water away from house. Do not cover any crawl space vents, weep holes in brick or bottom of siding (if applicable) with dirt or mulch. Half-circle wells are needed around crawl space vents.

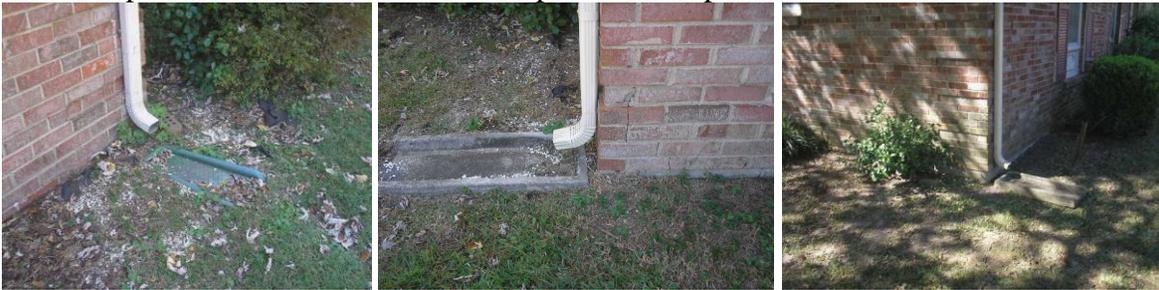
- 12.
13. It is important that roof and surface water drain away from the foundation to properly maintain the integrity of the foundation and maintain the area under the home. This includes keeping gutters and downspouts clean, and maintaining downspout extensions and splash blocks.
14. There is NO visible water standing in the crawl space at this time other than in the bottom of the sump pump pit near the crawl space door. See CRAWL SPACE notes below.
15. Position splash blocks better under downspouts and slope them AWAY from house.

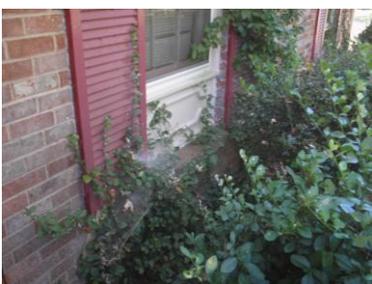
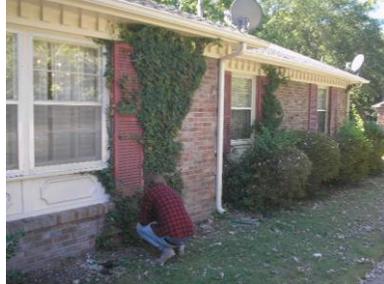
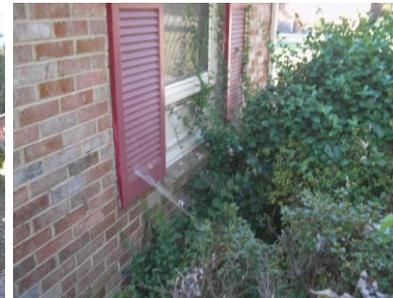
- 5.
- 6. Torn shingles noted on the shed.
- 7. Shed is locked, so I cannot inspect inside it.
- 8. Common cracking noted on concrete walks.
- 9. Ensure it is sealed off under the outside package HVAC unit and its metal shroud to help keep rodents out of crawl space. Use heavy screen wire outside and sheet metal in crawl space. No signs of rodents were seen in the crawl space at this time.
- 10. All shrubs should be trimmed at least 12" to 24" from the house to allow proper air circulation around the walls and HVAC units.

- 11.
- 12. Vines and other climbing plants can damage exterior surfaces by trapping moisture and by promoting another path for insects to enter the home.

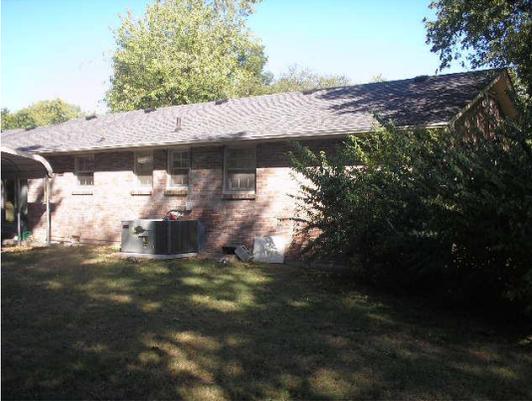
1. I could not see a lot of the exterior due to bushes, vines and trees hiding

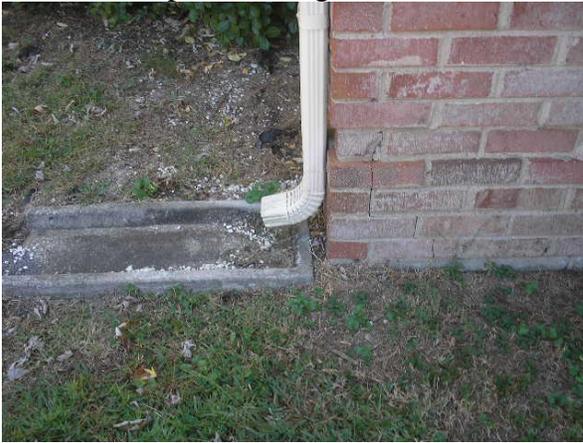
2. Lots of dents and scratches noted in the door from the old garage/family room to the outside.
3. There was a hail storm in the area on April 7, 2006.
4. Caulk the bottoms of all wood doorjambs, around doors, windows, and door thresholds as needed regularly.
5. Caulk the bottoms of all wood doorjambs.
6. Caulk around doors, windows, and door thresholds.
7. Common cracking noted on the front porch.
8. Extend dryer vent to outside with a hood with an outside flapper door.
9. Flashing around doors and windows is hidden and cannot be evaluated.
10. Common cracks noted in the bricks; like on the front right corner where downspout dumps out in a flat spot. Settling cracks in bricks are usually water drainage related.

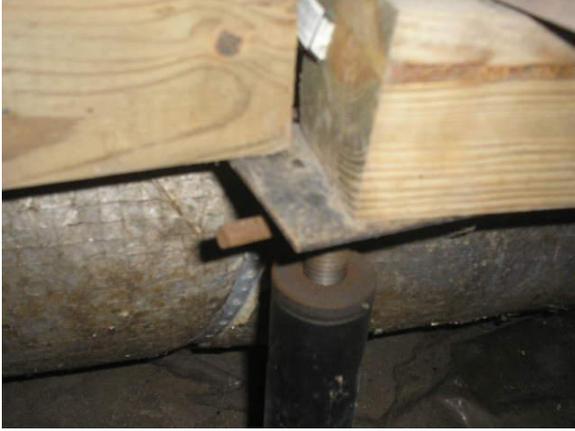
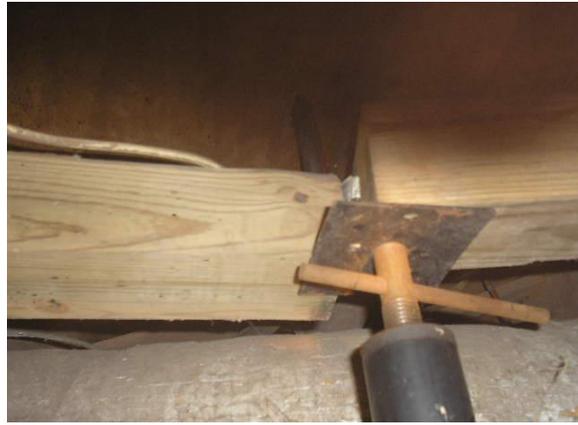
- 6.
7. Some of the temporary 4x4 beams are about to slide off their adjustable steel jack posts.

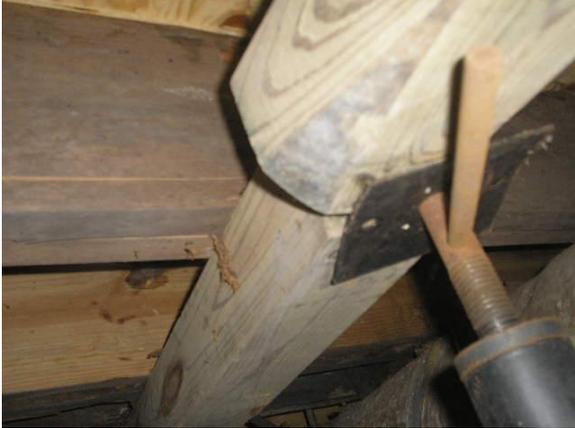
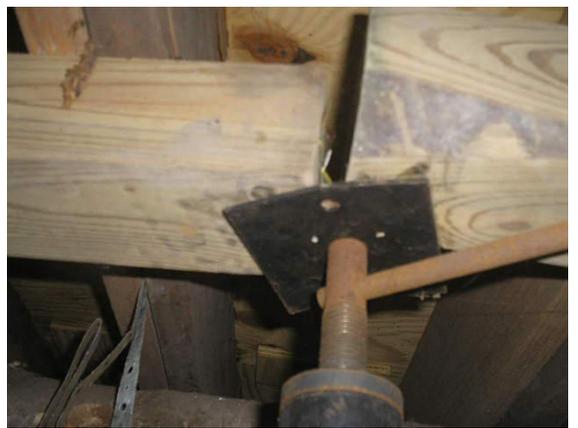
10. Adjustable steel jack posts are considered temporary since most of them are not secured at their tops or bottoms and they are adjustable.

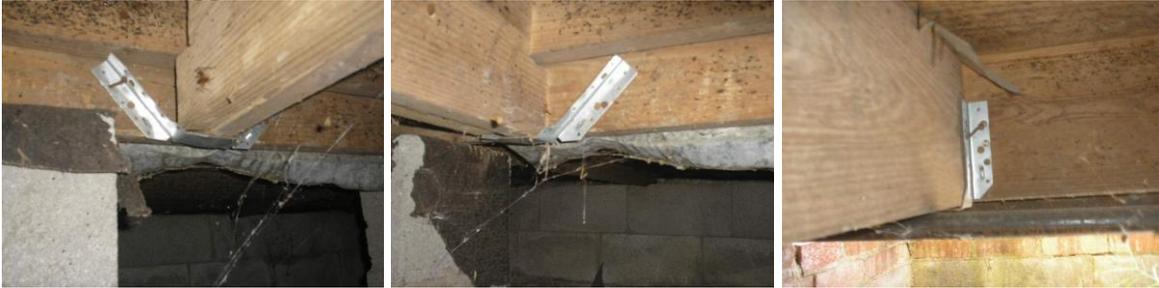
18. I occasionally find a few floor joists eaten up by fungus, but not to this extent.
19. There are some fungus veins in the deteriorated floor joists; like seen in the rear left crawl under the master bedroom.
20. Some new floor joists are added next to some of the deteriorated ones, but some of these are not properly supported.

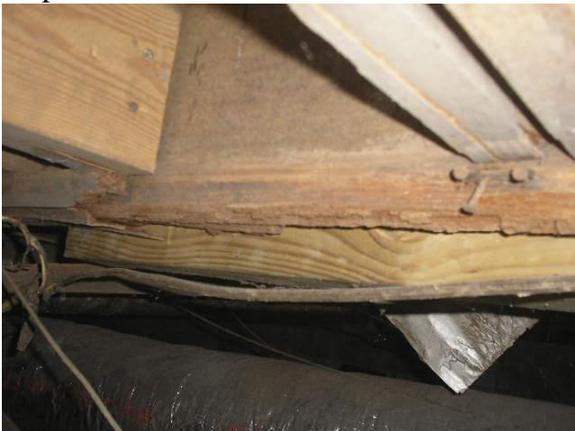
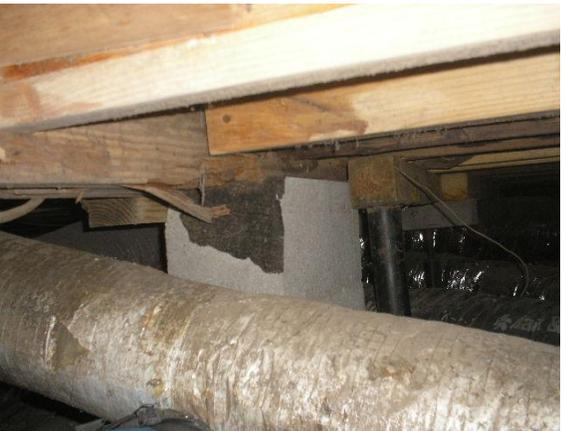
28.
29. In the crawl space, the 2x2 wood ledger strip that holds up the ends of the floor joists to the beam is rotted off in some places where the main wood girder beam that runs side to side down the middle of the house is rotted out too much to hold the nails which attach the ledger strip to the beam.

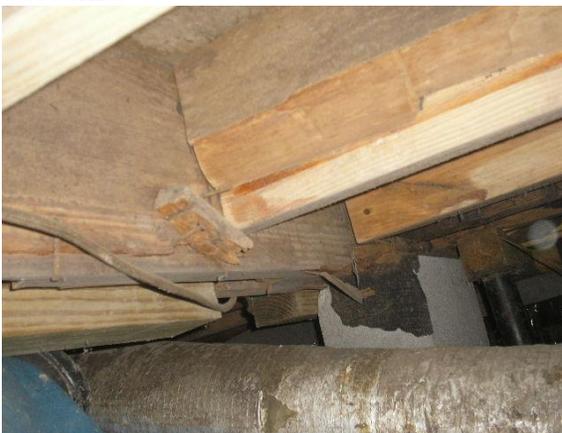
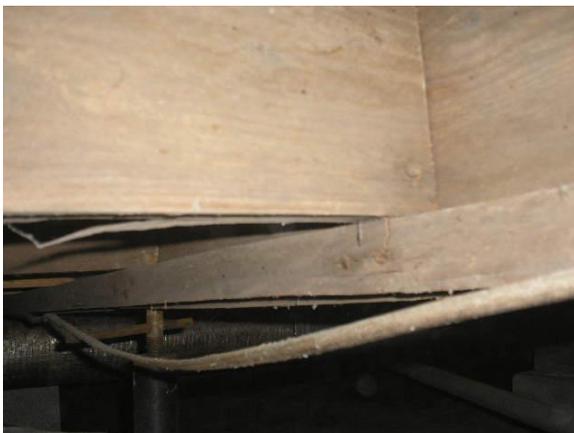
30.
31. In the crawl space, the main wood girder beam between the living room and kitchen is rotted out some.

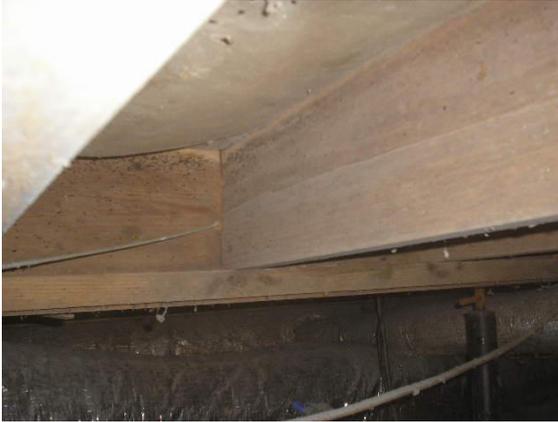
32.
33. One floor joist is split length-wise under near the center of the house.

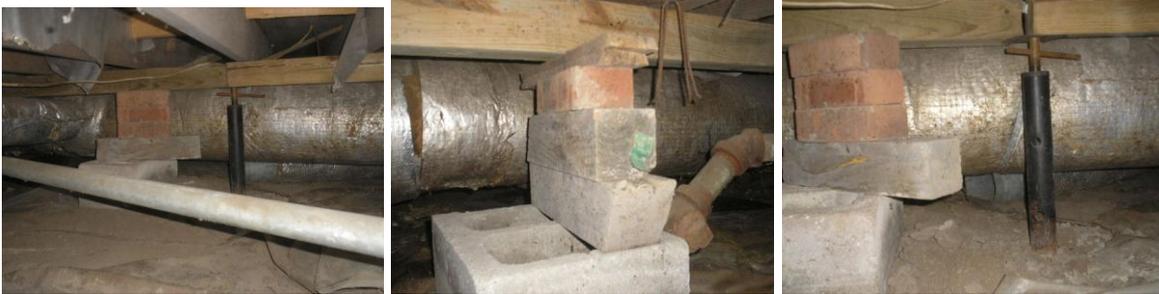
- 43.
44. In the crawl space, the 1x4 X-bracing has not been put back in place where the joists are rotted out and new joists added, like under the front center of the house.
45. In some parts of the crawl space, there are just loosely stacked wood blocks and bricks supporting the beam under deteriorated floor joists. I can move these blocks and bricks with my hands. These could fail at any time.

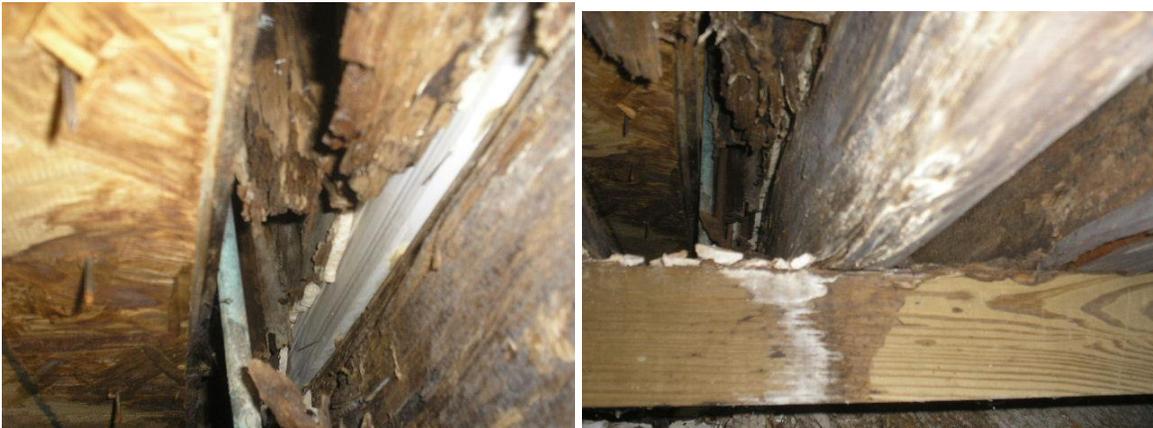
- 46.
47. It appears the current repairs were performed as a quick fix and are not done properly or permanently.
48. A lot of the 4x4 wood beams added are not attached to anything and some are about to slide off their adjustable posts.
49. A section of the bottom stud wall plate and bottoms of some wall studs are rotted out and missing under the hall bath wall. This can be seen from the crawl space where the floor is rotted out too.

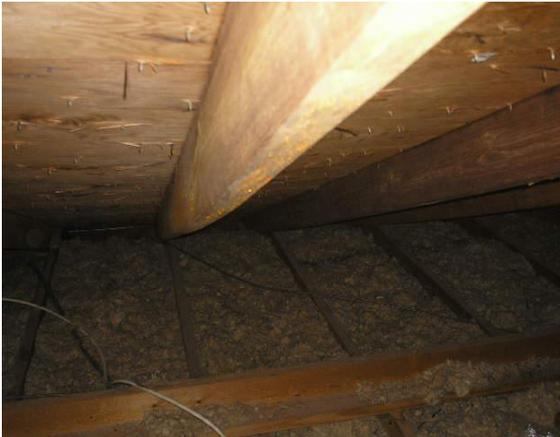
- 54.
- 55. A structural framing repair contractor needs to make the repairs needed in a permanent manor and signed off by a registered PE (professional engineer) after permanent repairs are made.
- 56. Adjustable steel jack posts are NOT permanent.
- 57. Waviness noted in the roof.

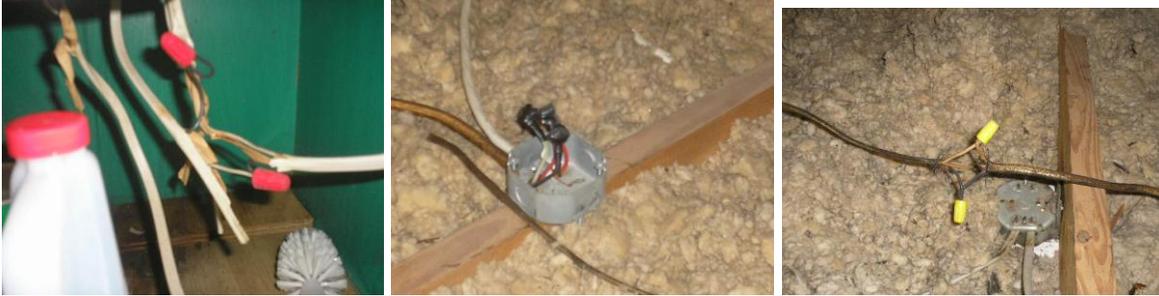
- Under the kitchen sink, wire connections for the disposal need to be in a covered secure junction box.

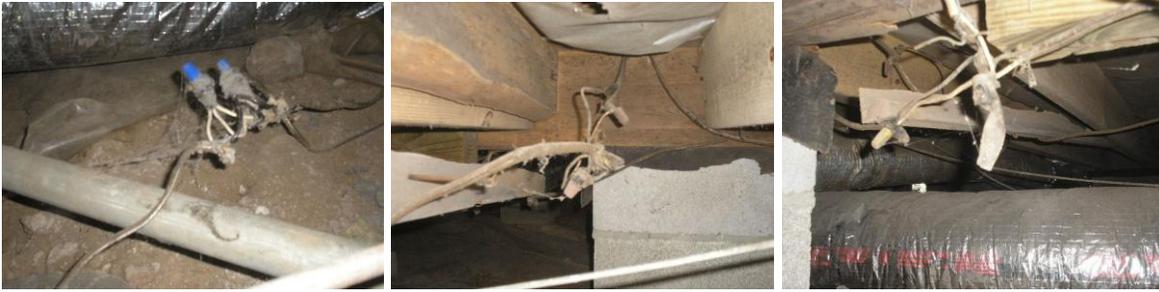
2.
3. There are several open junction boxes in the attic and crawl space.

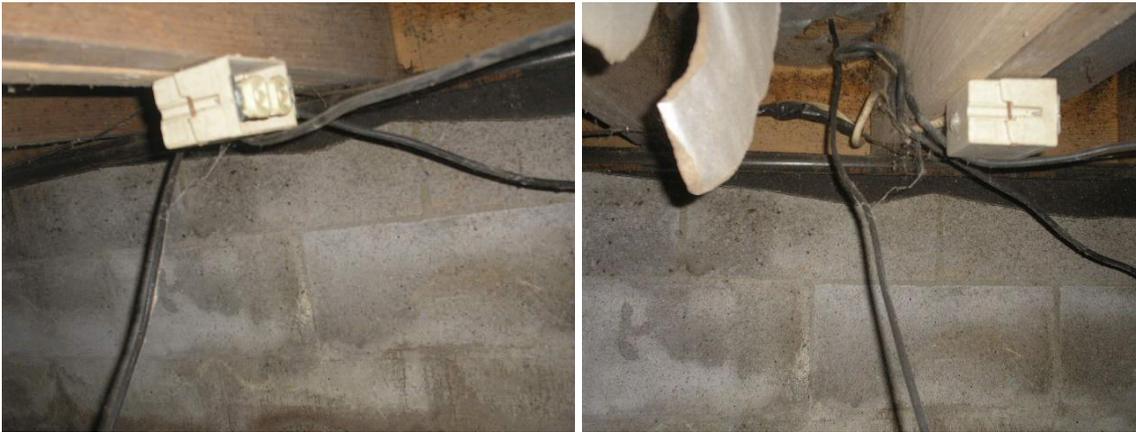
4.
5. The open electrical connections, like under the living room, need to be in covered junction boxes.
6. All electrical wire splices should be in covered and secured electrical junction boxes.
7. Outlet by the sump pump in the crawl space is missing its cover. It is not GFCI protected, and it should be.

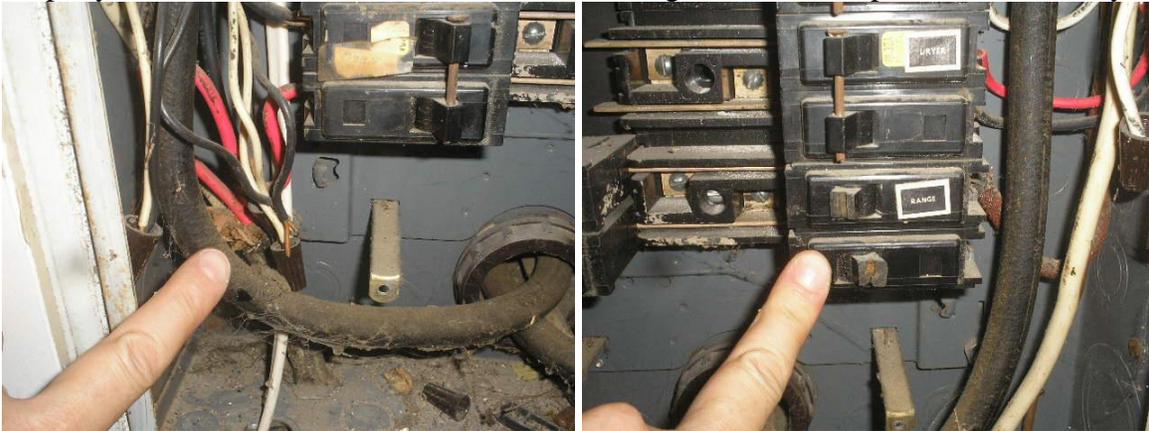
- 11.
12. Family room outlets have open ground wires.
13. Five screws are missing from the electric panel.
14. Due to the age of the home, most of the outlets are still the old two-hole outlets which do not have a ground hole. Some have been replaced with three-hole outlets which should be grounded, but some are still not grounded.
15. The one three-hole outlet in the master bedroom has an open ground wire. The third hole is supposed to be for a ground wire.
16. Properly terminate the ends of wires that are showing in the electric panel in the laundry.

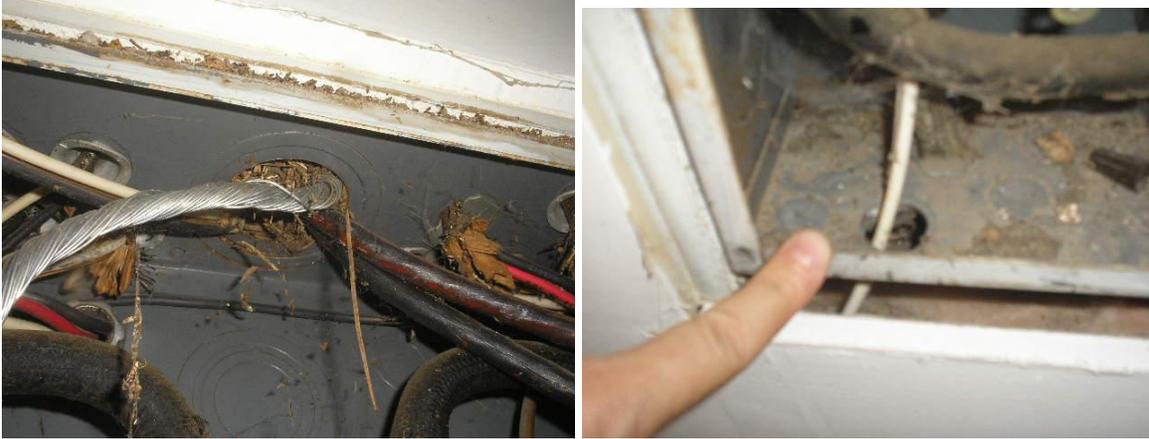
- 17.
18. Bottom right breaker in the electric panel in the laundry is turned off at this time. It does not have a wire connected to it. Its handle is partially broken off.
19. In the electric panel in the laundry, cable clamps are missing on two wires coming through the top of the panel and one wire coming through the bottom of the panel. Cable clamps protect wires from sharp metal edge of holes.

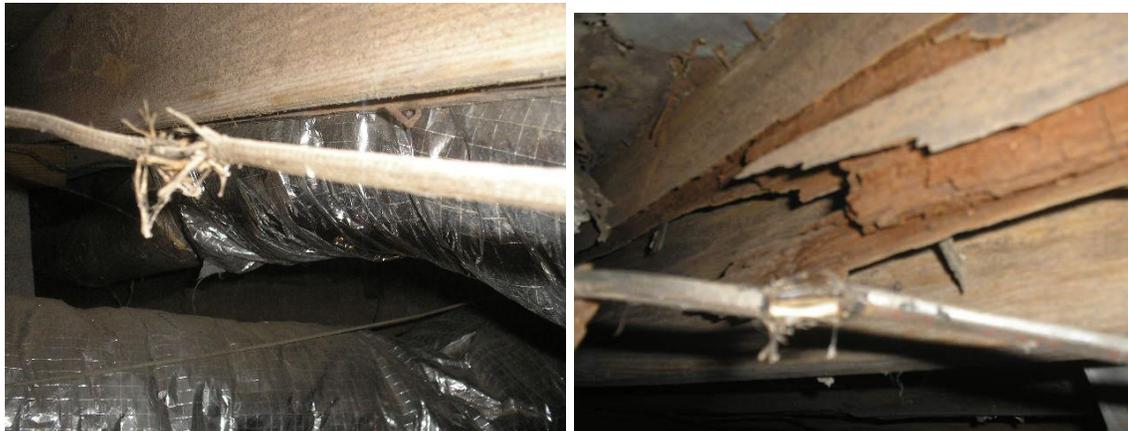
25. Label the breakers correctly in the electric panel in the laundry per codes.
26. In the crawl space, repair or replace the electrical wires where their outer protective insulation is missing where these wires were stapled to floor joists in the crawl space, but are torn loose where the floor joists rotted away. This is unsafe to someone crawling through and is a fire hazard.

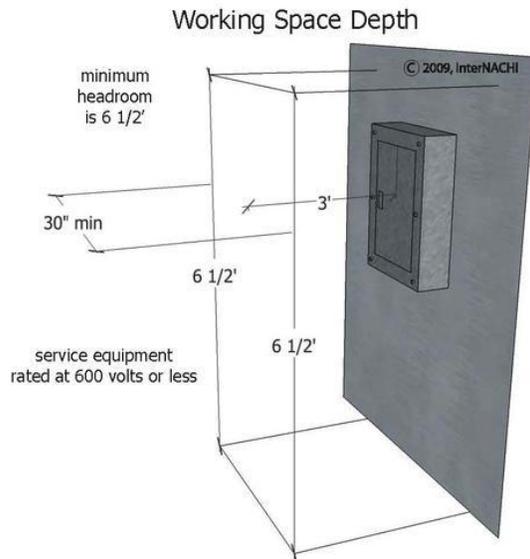
32. Install all cover plates and their screws on outlets, switches and junction boxes.
33. In the electric sub-panel, some white neutral wires are double taped to bus bar. It is preferred that each wire have its own individual hole and screw, so there is less chance of the wire coming loose. NEC (National Electric Code) 408.41 states that each grounded conductor shall terminate within a panel board in an individual terminal that is not used for any other conductor.
34. Main electric panel is above a washer or dryer. So you have to reach over it to access the panel. It should have at least 3 feet of clearance in front of it per codes.

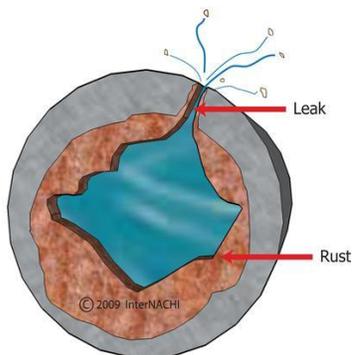
Galvanized Steel Pipe

- 4.
5. Handles are missing for the cutoff valve under the kitchen sink.
6. Dishwasher did not sound like it ran properly?
7. There is still some galvanized water piping, like seen under some sinks. It often fills with rust over time.

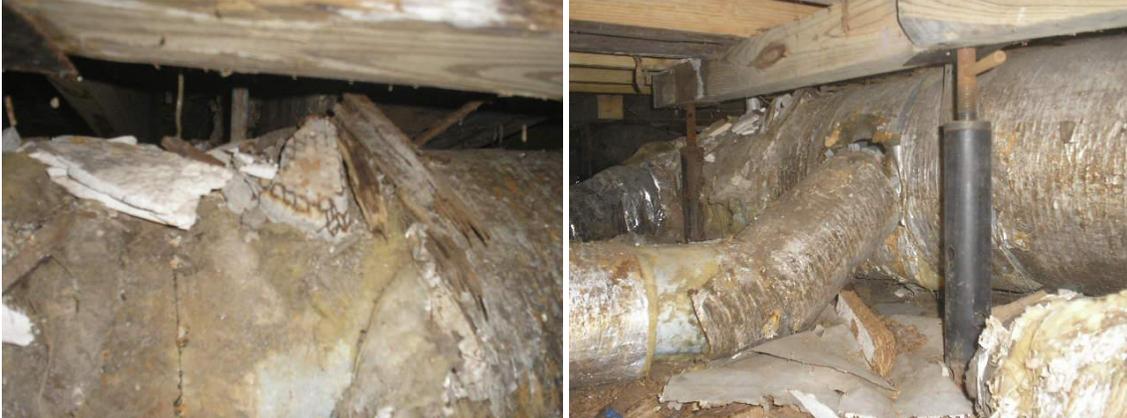
10. Ensure all leaks are fixed.
11. Drain stoppers are missing in the sinks and showers in both bathrooms.
12. Cut off and cap the commode floor bolts in the master bath.
13. Hall bath commode wobbles badly. Two of the four floor bolts are missing on this commode.
14. I was not able to crawl all the way under the bathrooms or kitchen to look for leaks without crushing ductwork. There are a lot of nails, metal and debris in the way, making it unsafe to crawl over it.

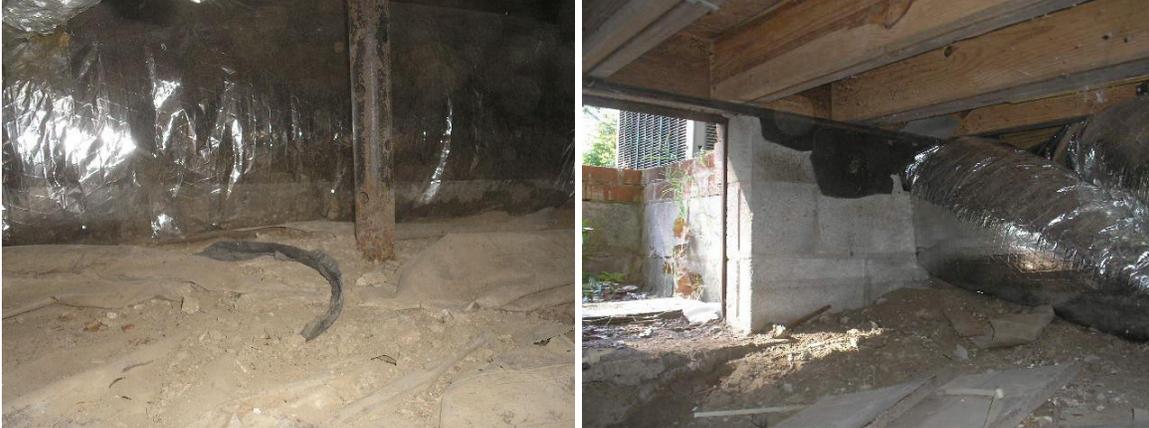
1. The outside hvac package unit's a/c tonnage appears to be approximately 2.5 tons x about 600 sf/ton = approximately 1,500 sf vs. 2,107 sf given. While it is better to be slightly undersized, this unit appears to be 1 ton or 600sf undersized. Manual J calculations can provide the exact numbers. However, most residential hvac professionals agree on the 600 sf/ton. The converted garage to Den may be about 600sf?
2. In the crawl space, there is about a 6" high water/mud stain on the outside of the main ductwork lying on the ground as seen from the crawl space access door. About 6" high water/mud stains are also on concrete block walls. This was probably from the May flood this year. Rain water probably ran into the crawl space vents that are right at ground level.

- 3.
4. Any ductwork that was in flood waters needs to be replaced due to contamination. City of Franklin usually requires this.
5. HVAC unit and other ductwork needs to be cleaned or replaced as directed by a professional.
6. The outside package hvac unit is higher than the crawl space ground, so it may not have been flooded. If it was flooded, it needs to be replaced as is usually required by the city of Franklin.
7. Ductwork should be up off the ground per codes.

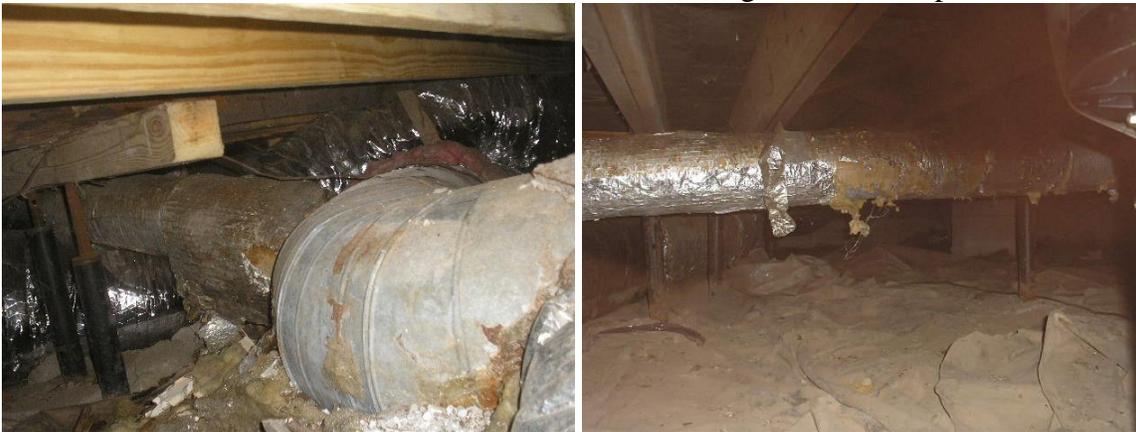
- 10.
11. Ductwork needs to be replaced.
12. Some of the insulation is torn off the ductwork and missing in the crawl space.

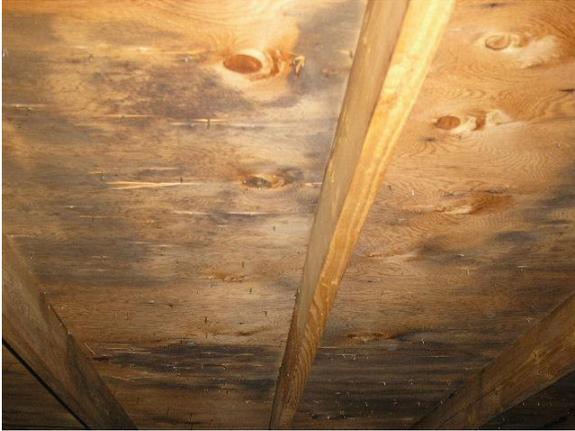
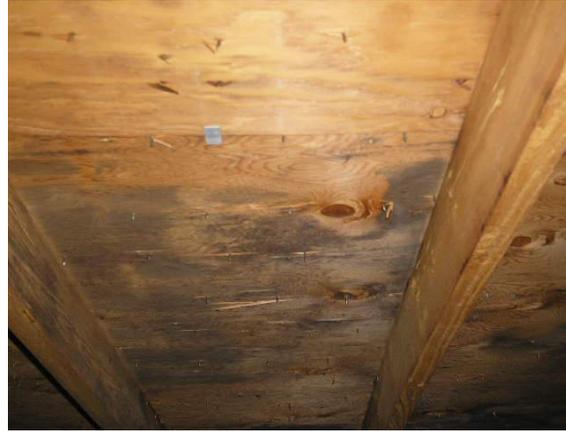
1. The pull-down attic stairs are missing proper fasteners in the open holes in both main metal side spring arm pivot plates. The WARNING label on the stairs usually calls for 1/4" x 3" long lag screws or 16d nails through the spring arm pivot plates, the corner brackets at the main header hinge, the opposite frame member and both side lengths of the frame. The use of sheetrock screws or finish nails are prohibited and can cause the stairway to suddenly fall from the opening possible causing bodily injury. Tighten all nuts, bolts and screws. This is a fall hazard!
2. There have been some roof leaks before.
3. Black stains on the attic side of the roof sheathing is often an indication of excess moisture from below. This could be due to the excess moisture rising up from the crawl space ground where there may have been no vapor barrier for about 30 years.

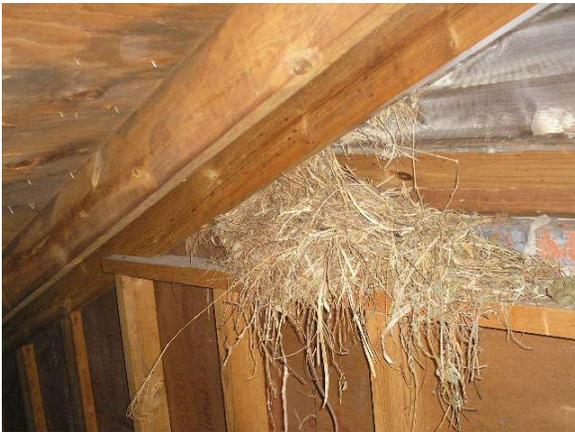
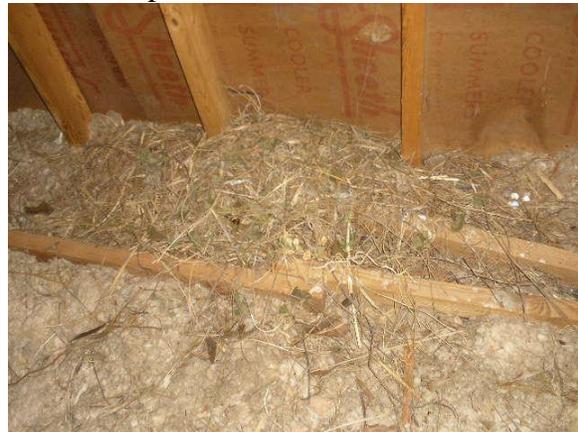
- 4.
- 5. There is a lot of bird nesting materials in both ends of attic at triangle gable vents, and a dead bird in the left attic. Ensure the vents are screened to keep birds out.

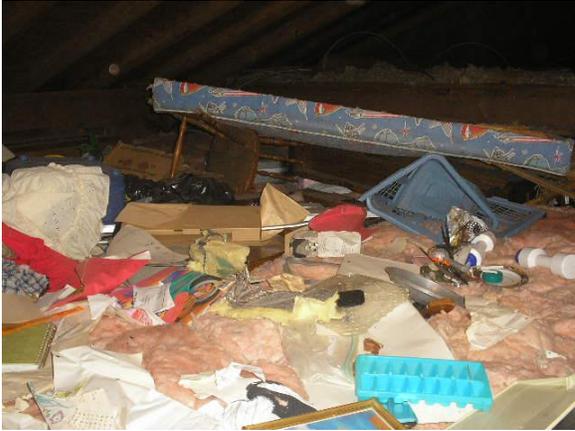
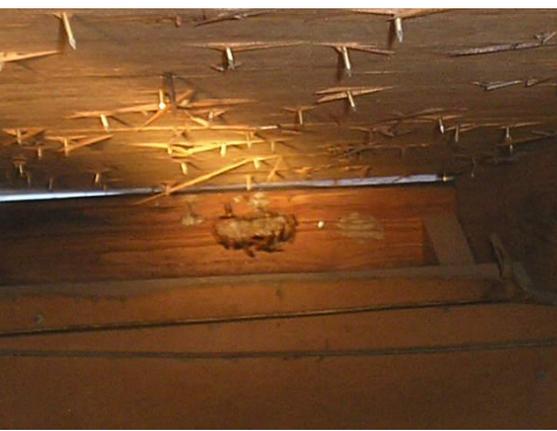
- 6.
- 7. Some of the attic is hidden by stored items.

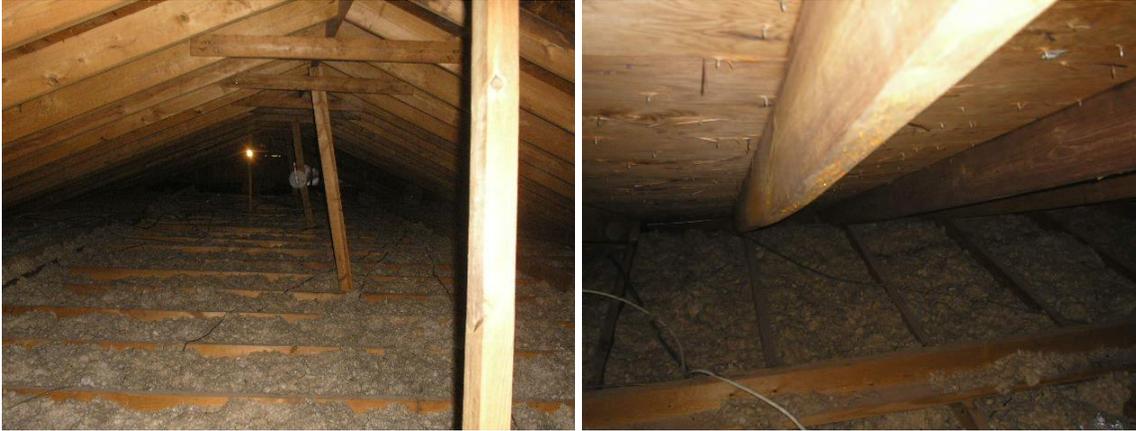
- 8.
- 9. There are large active wasps nests in the front and rear eaves where there are daylight gaps to the outside.
- 10. Ceiling above the Den that was the garage does not appear to be insulated under the plywood attic flooring where I can see under it. A thin layer of batt insulation is laid over some of the attic flooring here. But, it is not adequate.

- 11.
12. Add more blown insulation in attic. Where tops of ceiling joists are showing, insulation is only about 6" deep.
13. Attic insulation should be about 13" of loose fill for a desired R-38.
14. Typically, blown insulation should be kept at least 3" away from any recessed can lights unless the lights are rated for IC (insulation cover). I usually cannot tell if the can lights are rated for IC or not.
15. FYI- Exterior wall insulation is not visible, therefore, cannot be inspected.
16. FYI- Soffit and roof vents noted. Proper roof ventilation extends the roof's life and prevent internal sweating and excessive heat build-up.

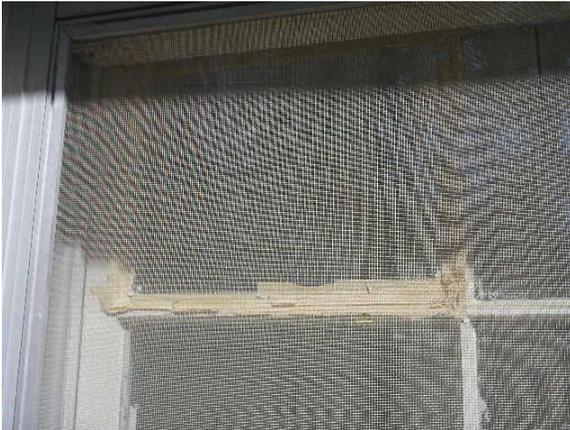
1. Some windows are stuck; like the window in the front right bedroom, left window in the master bedroom,
2. At least one window pane appears held in place with masking tape, like on the rear master bedroom window.

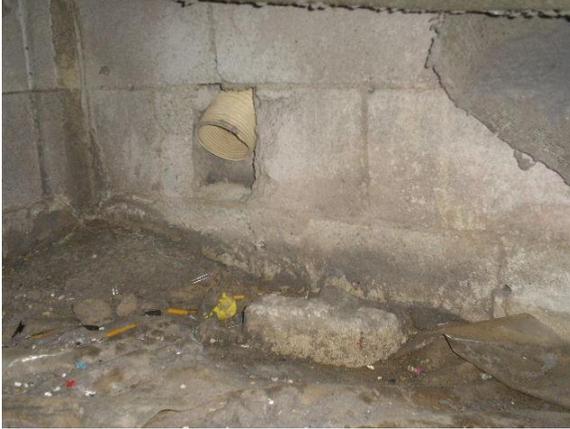
1. Dryer vents into the crawl space at this time.
2. Do not use dryer until this is corrected.

- 3.
4. Extend the dryer vent to the outside with a smooth metal vent pipe with a hood with a flapper door outside.
5. FYI- Clean the dryer vent hose and outside hood often.

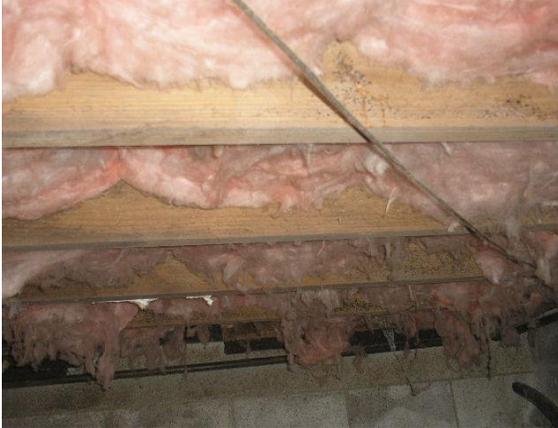
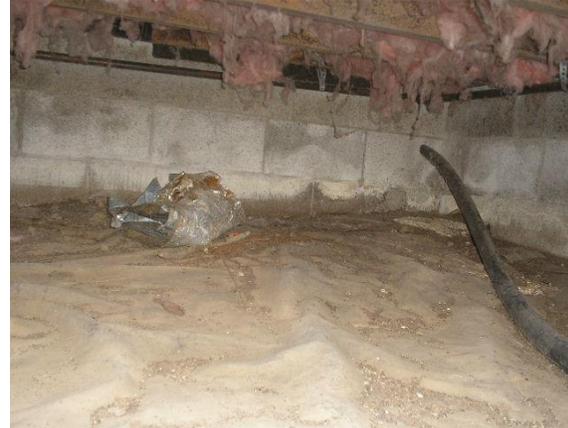
3. There is no insulation between the floor joists, except a small area under the master bed.

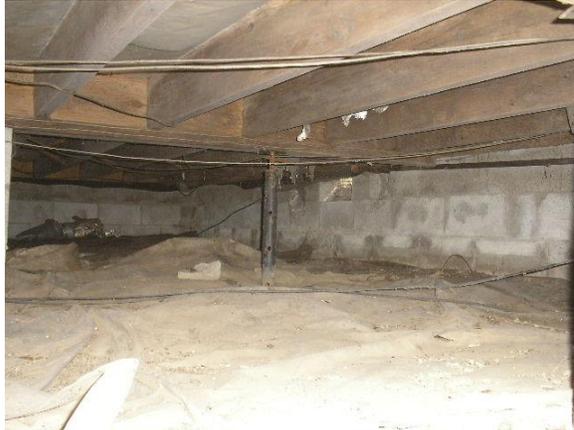
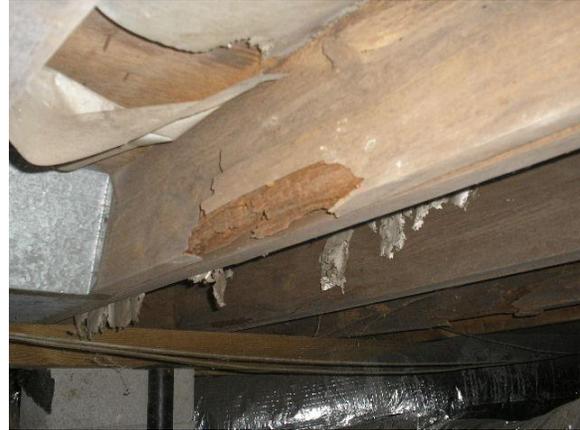
4.
5. I could not see the bottom of the wood sub-flooring except where some of the silver vapor barrier covering it is torn off.

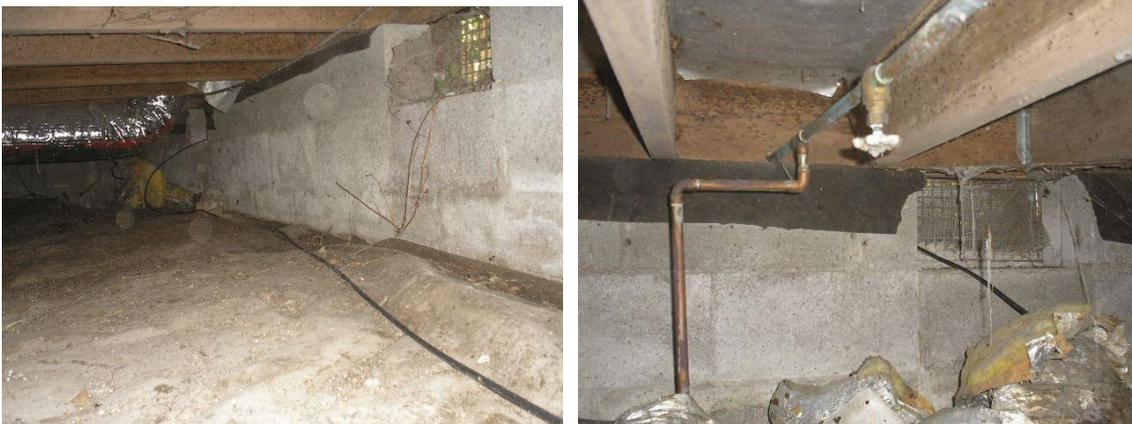
17.
 18. Sump pit should be secured down into the ground.
 19. I only recommend a sump pump as a last resort, since they are noisy and not dependable.
 20. I prefer the drainage to be taken care of so water never enters the crawl space to begin with.
 21. It appears water has flowed in some crawl space vents as seen on block walls.

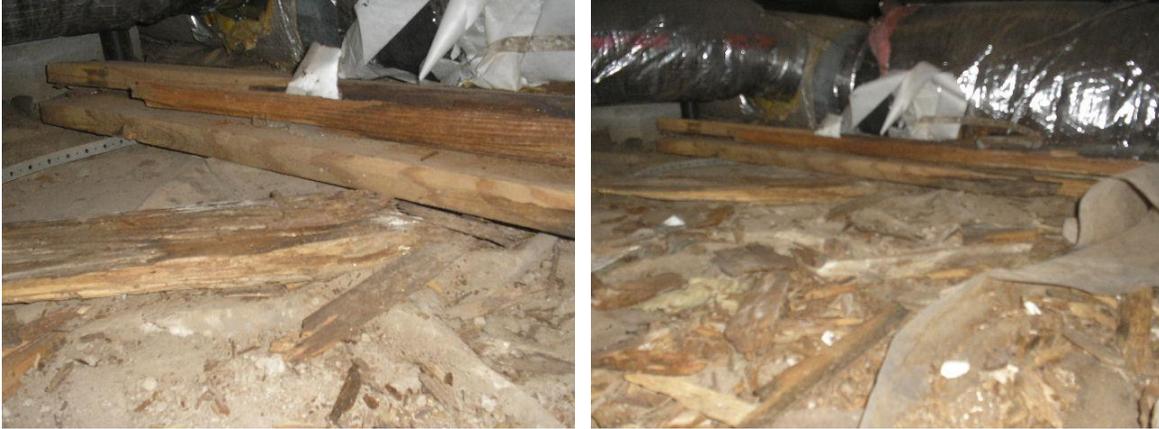
29. There are a lot of wood scraps, especially in the center of the crawl space where floor and framing rotted out badly.

- 30.
31. The ground is covered pretty well with 6-mil plastic vapor barrier, but there are some bare spots that need to be covered better. It is preferred that the plastic be sealed at its edges and seams. Ensure it remains covered wall to wall to help reduce mold and mildew. Overlap seams and provide extra at walls.

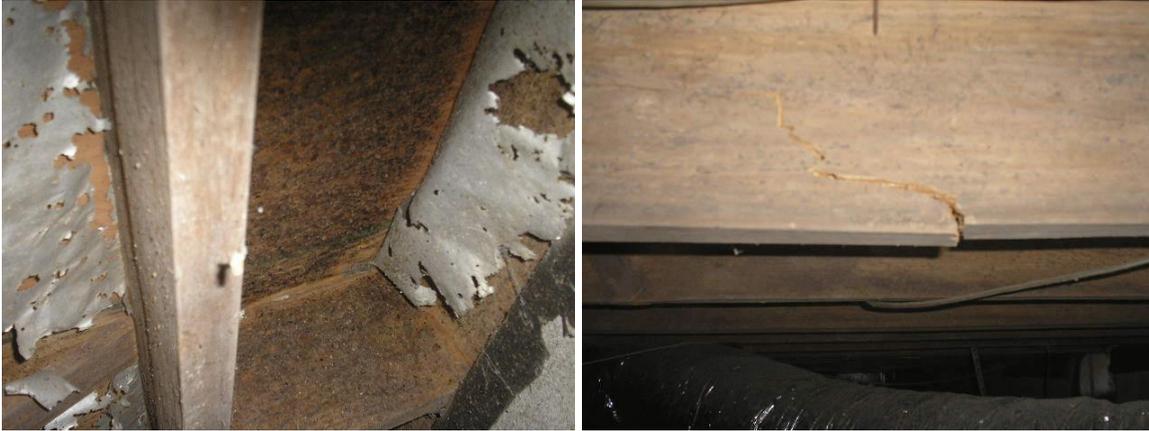
35. Some mold-like substance noted on wood framing and sub-flooring in the crawl space. A lot of the dark areas appear to be cave cricket waste.

36.
37. There are a lot of cave crickets in this crawl space.
