**123 Any Lane, Brentwood, TN**

## **HOME INSPECTION REPORT**

Evaluation of property located at: **123 Any Lane, Brentwood, TN**

Time of the inspection is: **July 5, 2010 9:30 AM to 12:06 PM**

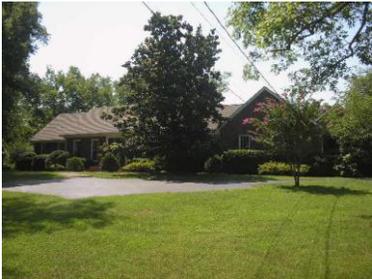
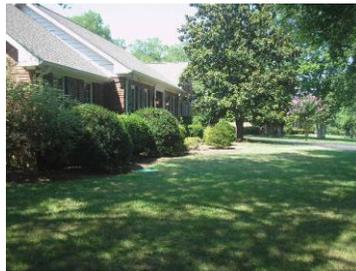
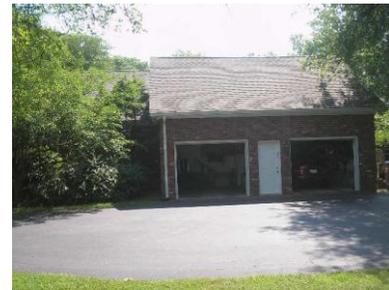
- 13.
14. All shrubs should be trimmed at least 12" to 24" from the house to allow proper air circulation around the walls and HVAC units. Vines and other climbing plants can damage exterior surfaces by trapping moisture and by promoting another path for insects to enter the home.

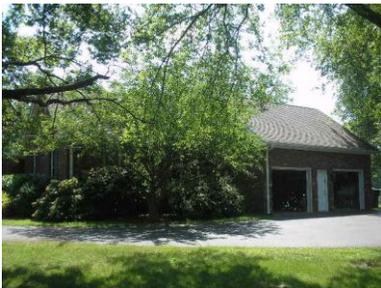
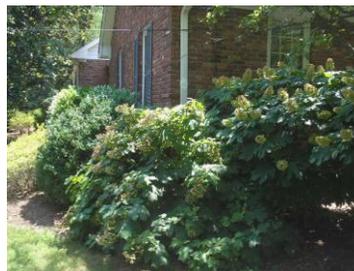
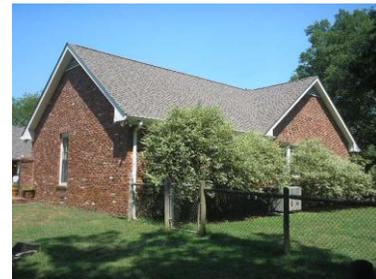
- 15.
16. I could not see most the exterior very well due to the overgrown bushes hiding the exterior of the house.

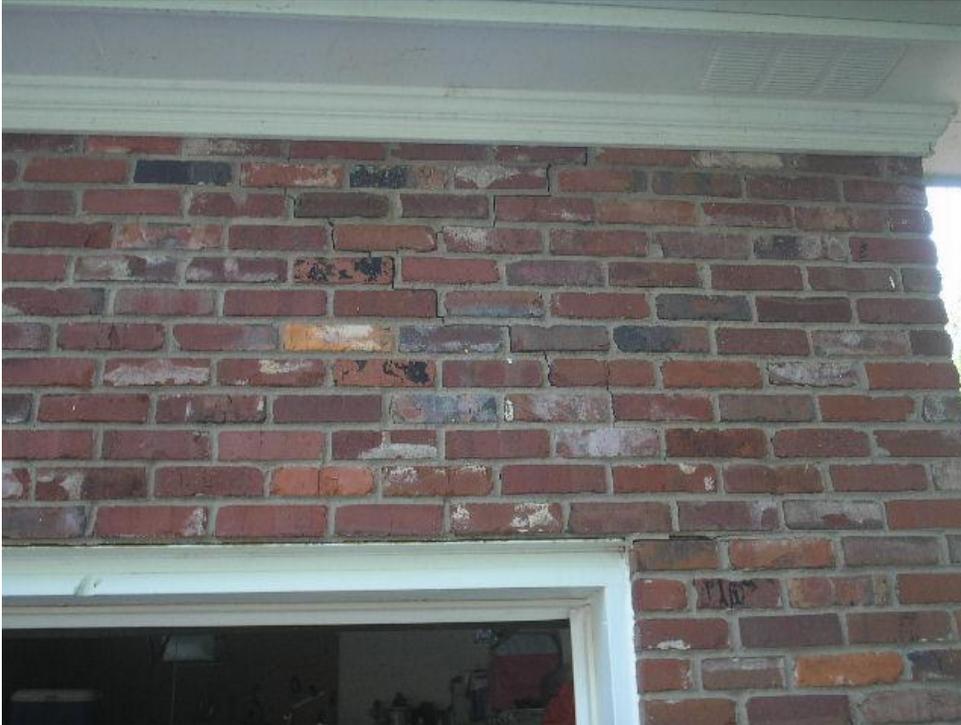
- 2.
3. Some soft spots noted on some wood window trim, like on rear,
4. Cracks noted in the stained glass panels in the master bedroom windows. There is a clear piece of glass over the outside of the stained glass panels.
5. About 1/8" to 3/8" wide cracks noted in the brick mortar joints above the rear overhead garage door.

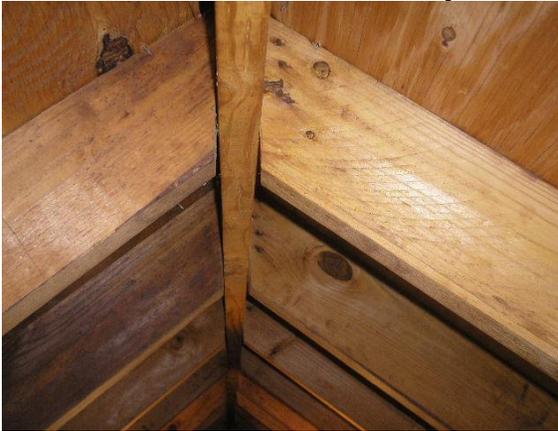
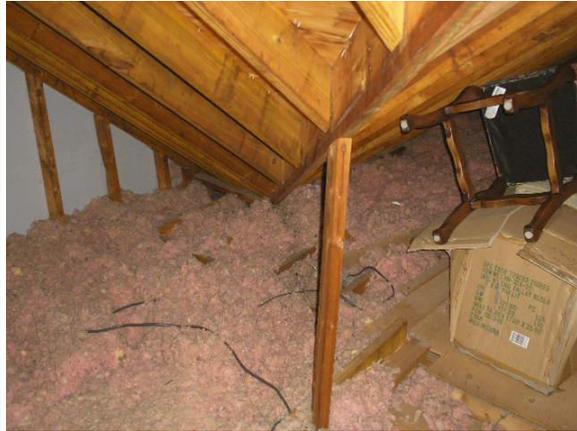
1. In the attic, horizontal wood ridge boards are not the full depth of the upper mitered ends of the roof rafters. Per codes 2320.12.3 and 802.3, ridge boards must be full depth of the mitered ends of the rafters, and they are not here.

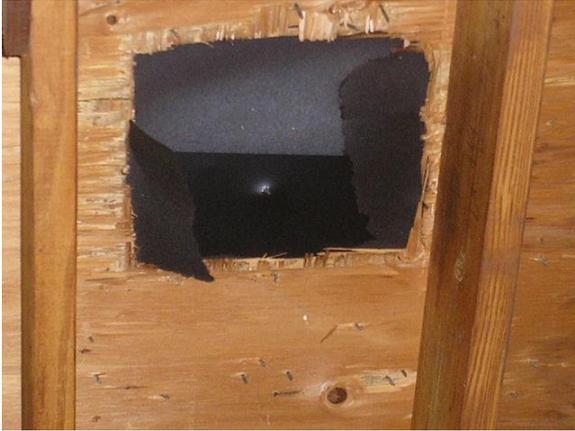
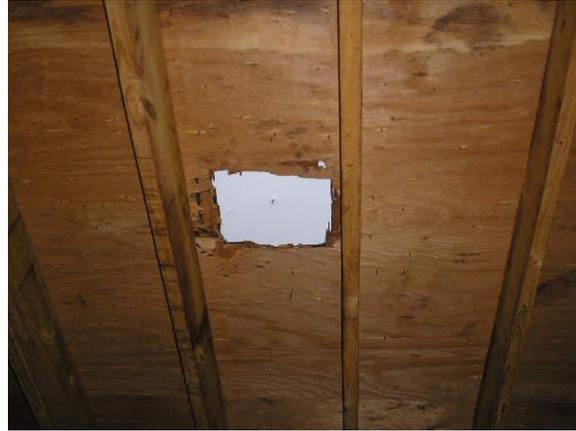
- 2.
3. Under the roof valleys in the attic, there is only a single 2x4 under the middle of the roof valley rafter. It should be a double 2x4 with one 2x4 perpendicular to the other to make a stiff-back angled support post.
4. In the attic, reinforce the plywood roof sheathing spots where roof box vents have been removed and only a thin sheet of metal covers their openings.

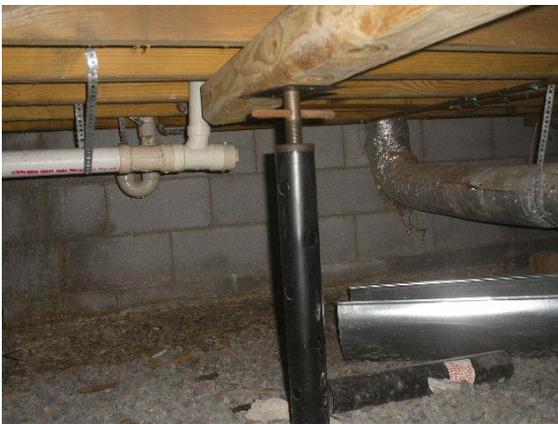
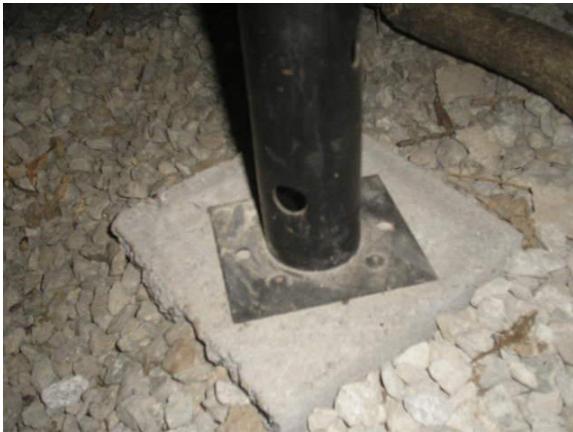
- 5.
- 6. In the crawl space, there are a lot of adjustable steel jack posts that are not secure at the top or bottom.

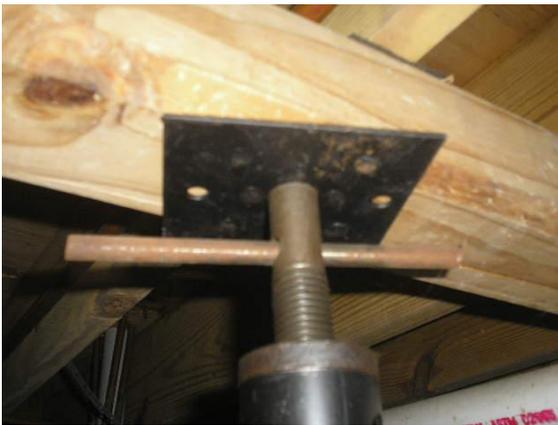
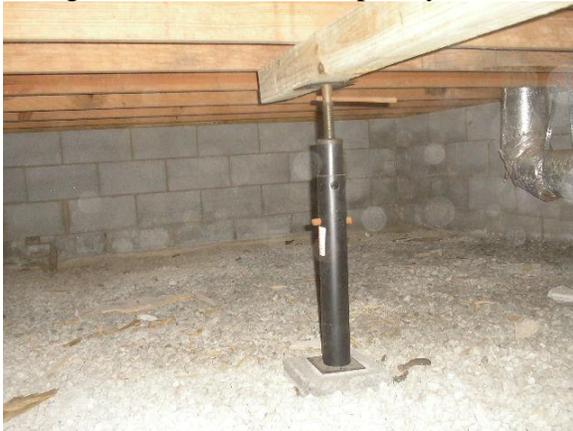
- 7.
- 8. They are just sitting on small blocks on top of the ground. These are temporary.

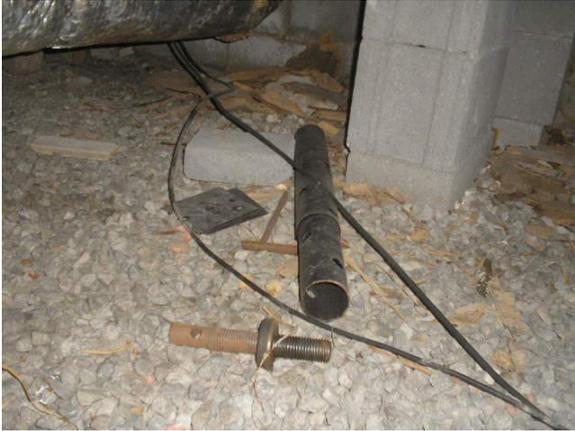
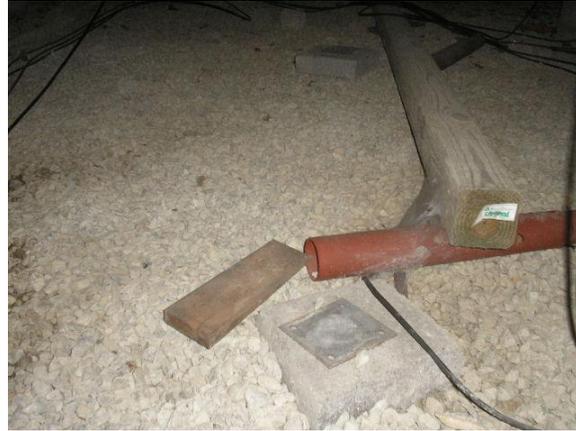
- 9.
- 10. They are near the middle of the floor joist spans to help eliminate bounce in the floors. Some of these supports are fallen over and laying on the ground. These supports need to be made permanent.

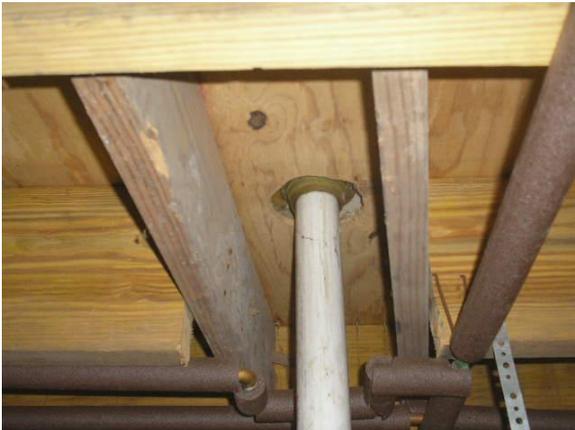
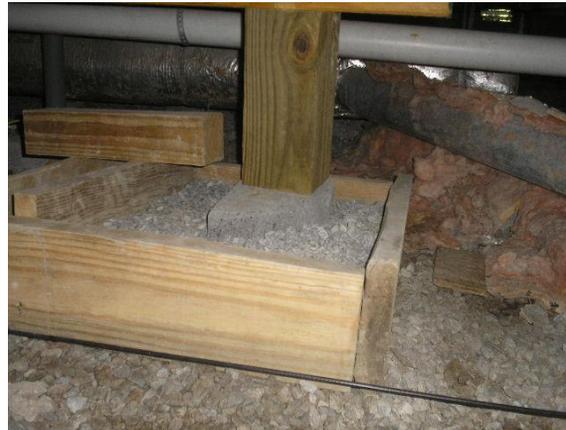
- 11.
12. In the rear right crawl space, adjustable steel jack posts are fallen over. I often find these temporary posts fallen over since they are not secured.
13. In the crawl space, one wood floor joist cut in two for a PVC drain line, and is only headed-off with an old board. It needs to have a proper full-depth wood header to support both cut ends of the floor joist. The headers should have metal Simpson joist hangers with Simpson nails.

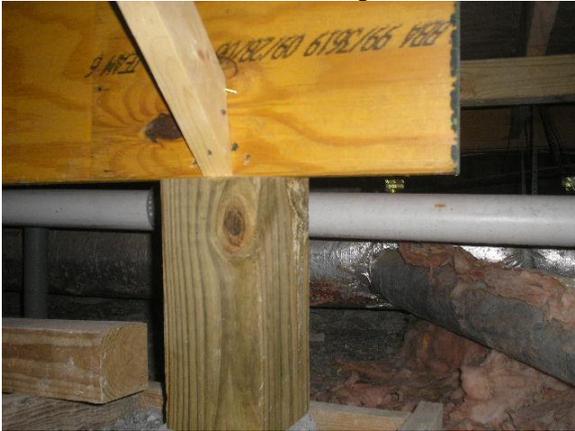
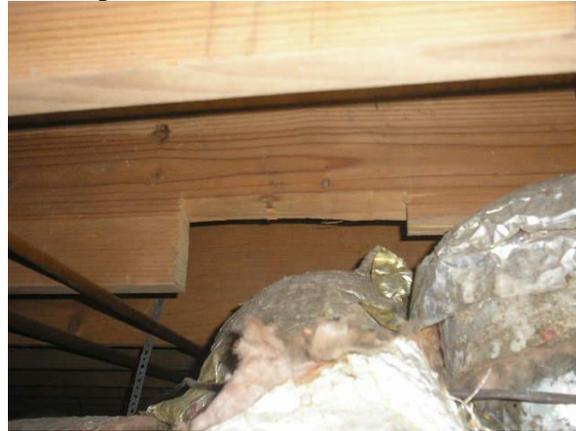
- 14.
15. In the crawl space under the kitchen, two concrete pad footings have been poured with 6x6 pressure treated posts and a wood beam across them. The beam is not attached to the wood posts, and the wood form boards are still in place on the ground around the concrete pads. There are a lot of wood scraps here and under the fireplace area too.

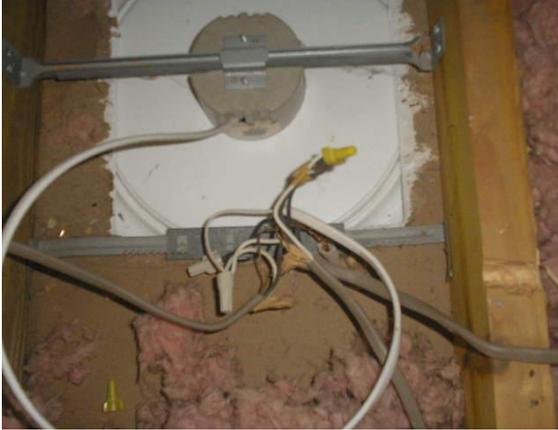
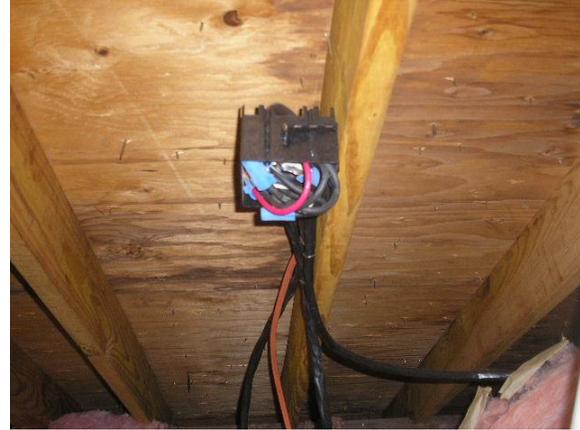
9. A ground fault circuit interpreter (GFCI) is a modern electrical device. It can be a receptacle or a circuit breaker, which is designed to protect someone from a potentially fatal electrical shock. GFCI's are now required in all wet and damp areas of all new homes. In the event of a fault in an appliance that you are touching, the current that passes through your body to the ground is detected and the circuit is shut off, protecting you from a potentially fatal shock. We strongly recommend that all receptacles in baths, kitchen, garage, at spas, hot tubs, pools, fountains, crawl spaces, outdoors, and all wet locations be the GFCI type. Resets are sometimes located in the garage.
10. There are some open electrical splices and open electric junction boxes in the attic.

- 11.
12. There are some open electrical splices that need to be in covered junction boxes, like in the attic above the garage.
13. All wire splices should be in covered junction boxes per codes.

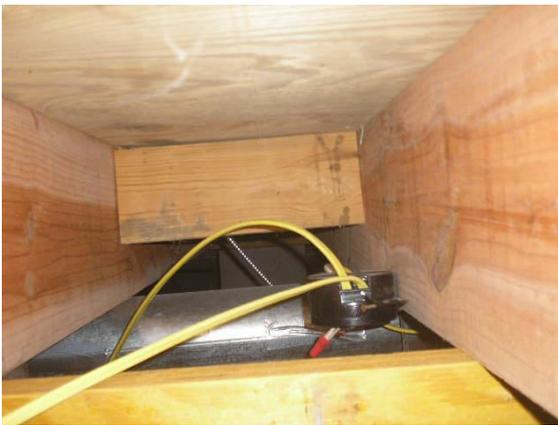
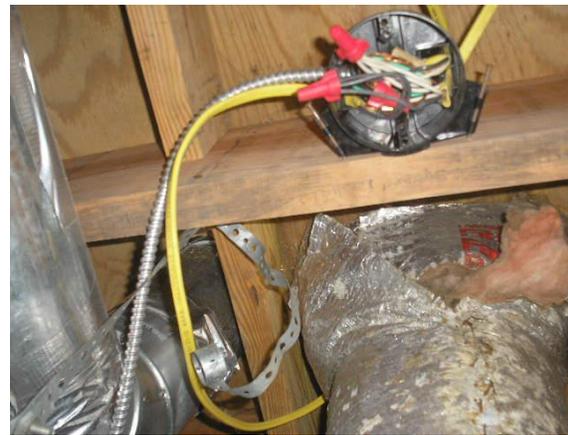
- 20. In the crawl space, the wiring has open junction boxes, and wires are not stapled within 12" of the box.

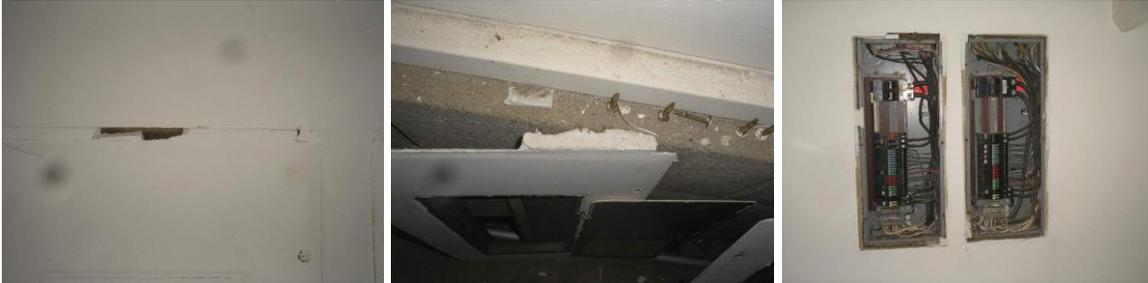
27. Light is out in the rear-most closet in the front left bedroom.
28. I did not see the flood lights come on.
29. I did not see the light come on above the left shed door.
30. One light is out in the attic above the garage.
31. I did not see the lamp post at the pool come on.
32. Install all cover plates and their screws on outlets, switches and junction boxes.
33. A licensed electrician needs to make all the electrical repairs.
34. Due to the age of this home, I recommend having an electrician turn off the power and tighten all wire connections inside both panels in the garage.
35. There are gaps around the two main 200-amp service disconnect breaker panels in the garage. Their edges have some drywall mud over them, and when I carefully removed the panels, some chunks of drywall mud fell out, leaving gaps.

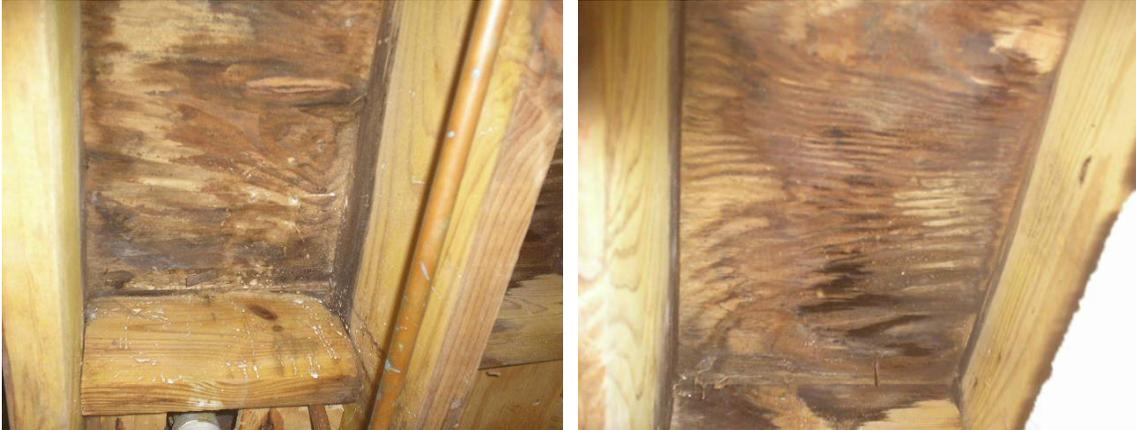
4. Sub flooring is rotted under master whirlpool tub as seen from the crawl space.

11. At wet or rotted floors; fix leaks, remove any material with mold on them, treat area for mold, let it dry out completely, then repair/replace and reinforce wood flooring.

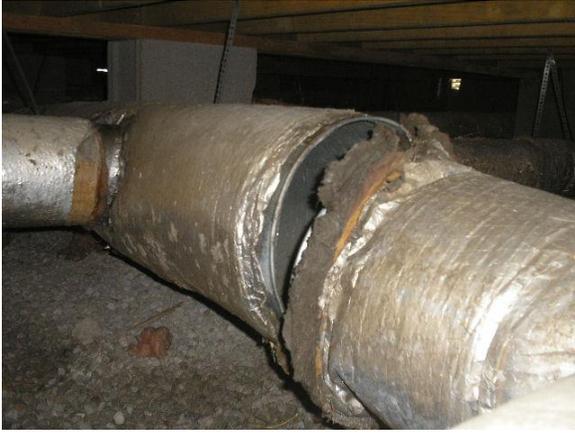
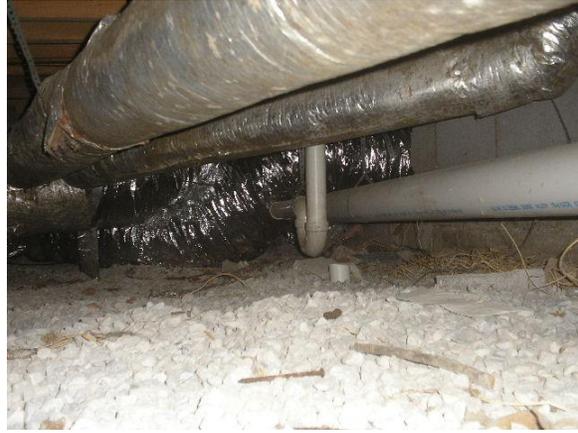
- 8.
- 9. In the center crawl space, the main supply air duct trunk line is torn almost completely in two under the family room by someone crawling over it. Inspect inside ducts and clean them,

since they have been exposed to the damp crawl space air. There is no plastic vapor barrier over any of the crawl space ground, and the dryer is venting into the crawl space since its vent pipe is pulled apart.

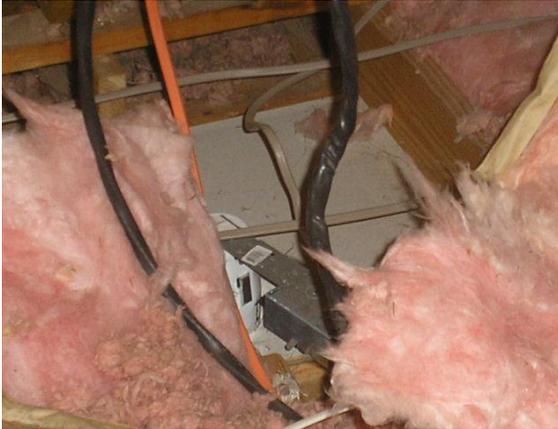
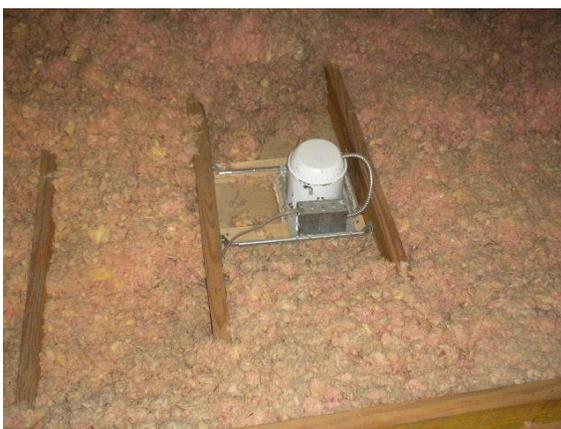
- 6.
- 7. Drywall ceiling is showing in places where there is no insulation.

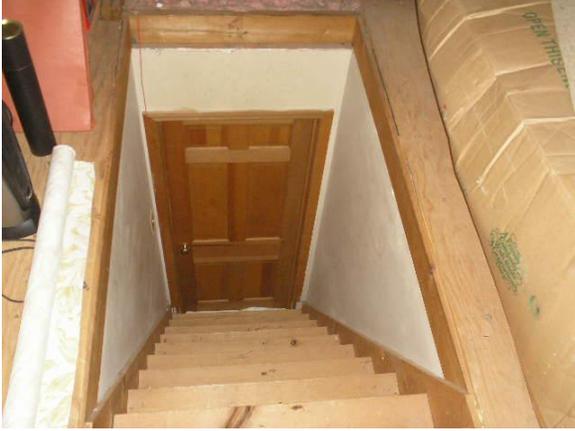
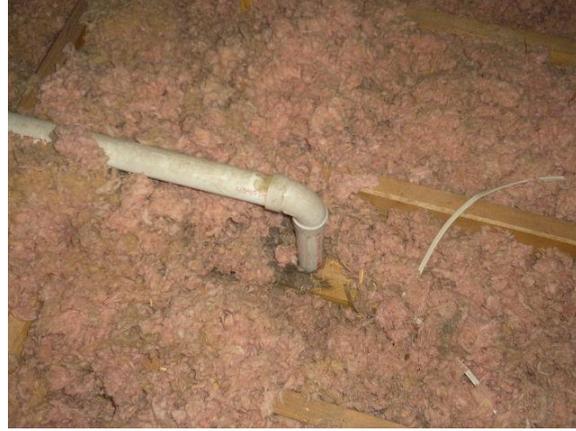
- 8.
- 9. Insulation is thin in other areas too.
- 10. The walk-up attic stairs are steep, have narrow treads and have no handrails.

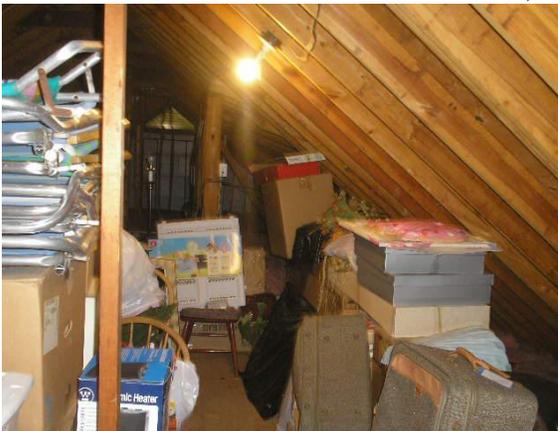
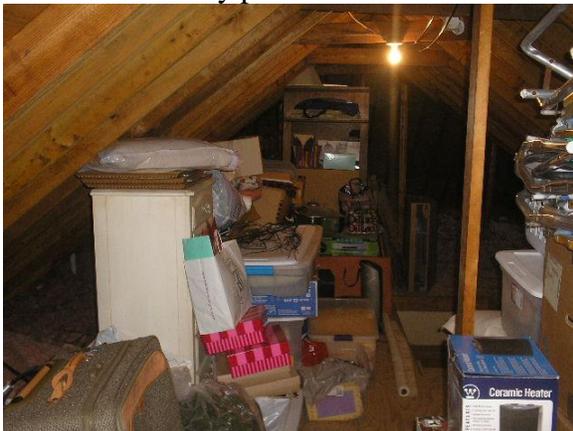
15.   
 16. There are a lot of stored items in the attic, so I cannot see every part of the attic.

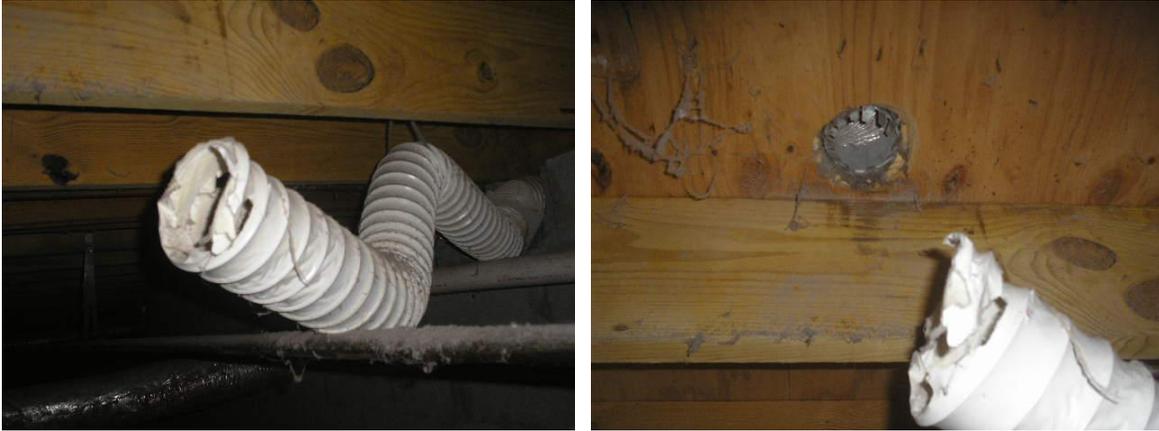
1. Dryer vent hose is disconnected in crawl space. Replace this white vinyl hose with a proper smooth metal pipe.

- 2.
3. Flammable vinyl duct used to vent dryers is a serious fire hazard. It should NOT be used as dryer vent, or even a connector between the dryer and vent.

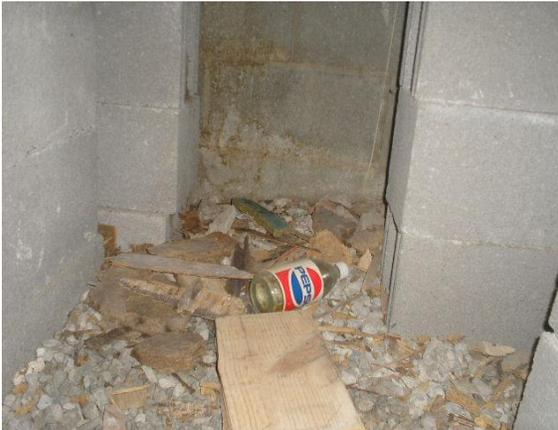
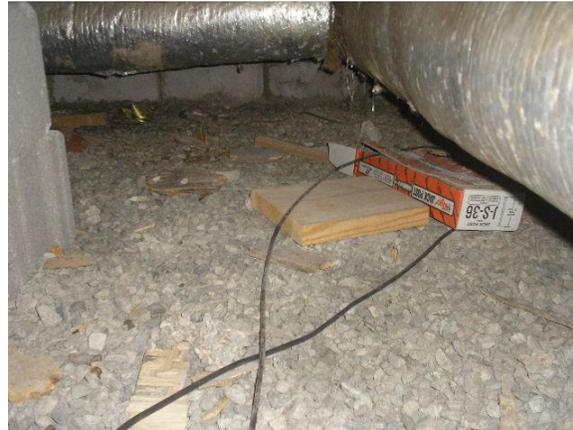
- 12.
13. There are water stains and rot on the flooring under the rear right bath and master bath. Ensure leaks are fixed. Treat for mold. Reinforce floor.
14. Common dampness on ground and concrete block walls around the perimeter foundation walls in the crawl space.
15. Improve the exterior drainage to eliminate dampness in the crawl space as noted under LOT DRAINAGE notes at the beginning of this report.
16. Some drainage contractors add a French drain along the perimeter foundation walls either inside or outside of the crawl space.
17. There are a lot of wood scraps, cardboard and debris on the ground under the fireplace and kitchen. This is termite food.

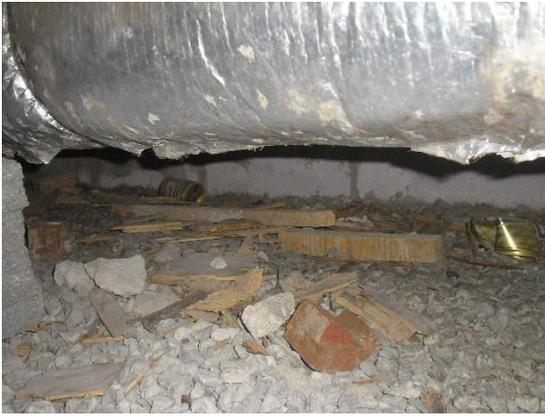
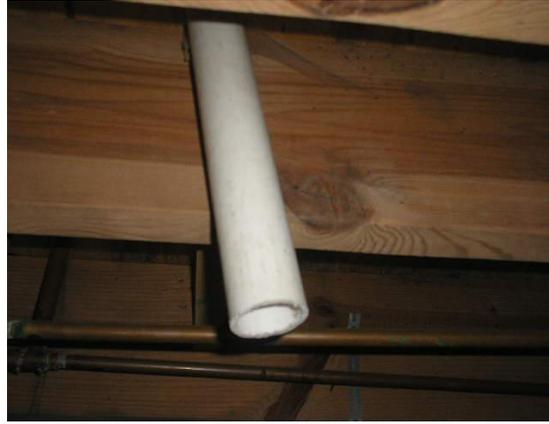
- 18.
19. Remove all wood scraps and debris from the ground under the house, especially from under the plastic. Wood on the ground in the crawl space invites termites. Rectangular plywood scraps are often found on the ground where the sub-flooring is cut out for each of the air supply vents through the floor. Metal termite shields are not seen here and are rarely seen anymore.

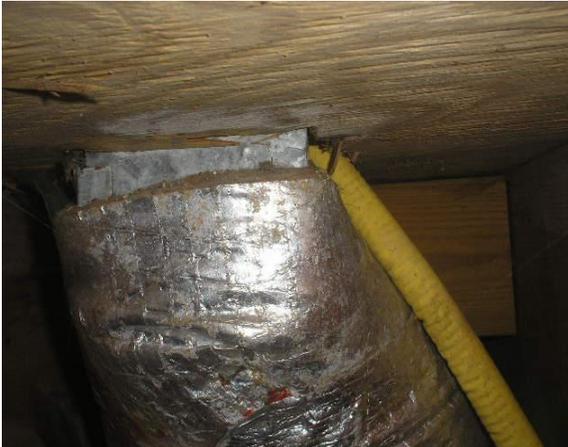
- 20.
21. Ensure the pvc drain line sticking down into the crawl is only from an overflow pan.
22. There is no vapor barrier over the ground. Crawl space ground is gravel.
23. The ground should be completely covered pretty with 6-mil plastic vapor barrier. It is preferred that the plastic be sealed at its edges and seams. Ensure it is covered wall to wall to help reduce mold and mildew. Overlap seams and provide extra at walls.
24. Some pipe insulation is off water lines in crawl space.
25. The yellow flexible gas line is run up through the sharp metal ductwork under the kitchen. This is not advisable.
